FIRNTEC
BUILDING COMPLIANCE

VISUAL STRUCTURAL APPRAISAL

89 Laburnum House

Bradwell Avenue
Dagenham
RM10 7AE

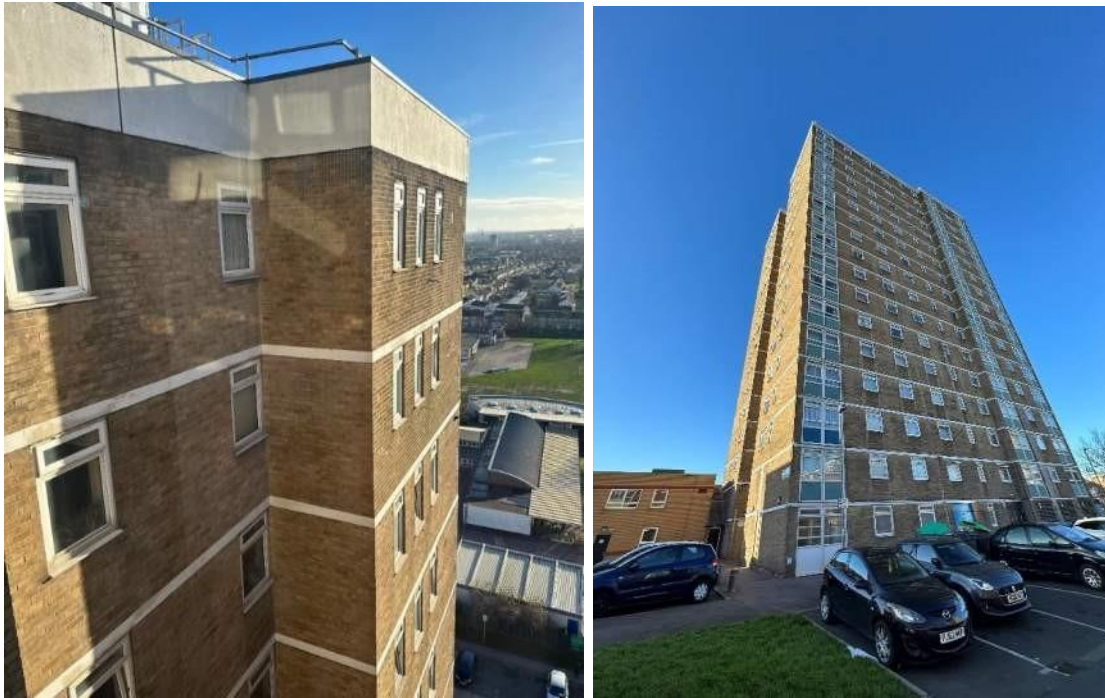
Figure 12 and 13: Close up and overview of elevations

The exterior elevations were generally in ok condition and no significant structural defects were noted to the cladding panels. There were no significant cracks or tell-tale signs of any significant structural movement noted at the time of our inspection.

The external cladding system is constructed as a cavity wall, with a stretcher bond to the outer leaf. We were unable to see within the wall cavity to confirm whether there are ties or masonry supports present. The exterior walls were noted to be plumb with no signs of significant bowing, bulging or leaning noted to the cavity walls indicating failed fixings, however their presence and condition cannot be confirmed.

It was not possible to inspect the lintels over the window opening however due to the building type we would expect a slab thickening over each opening.

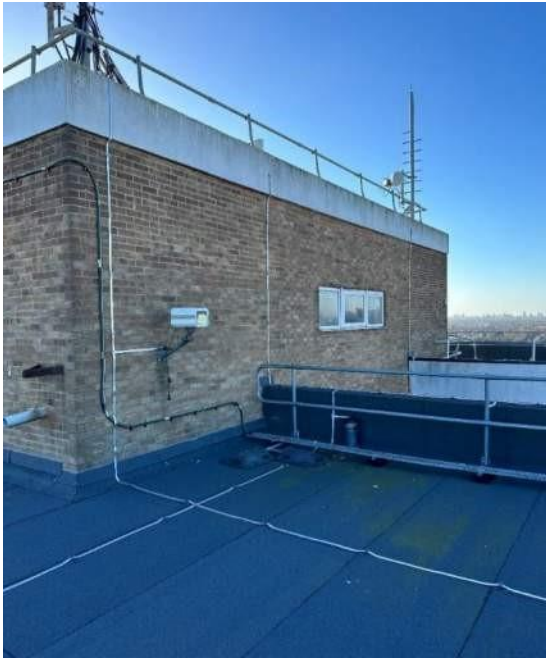
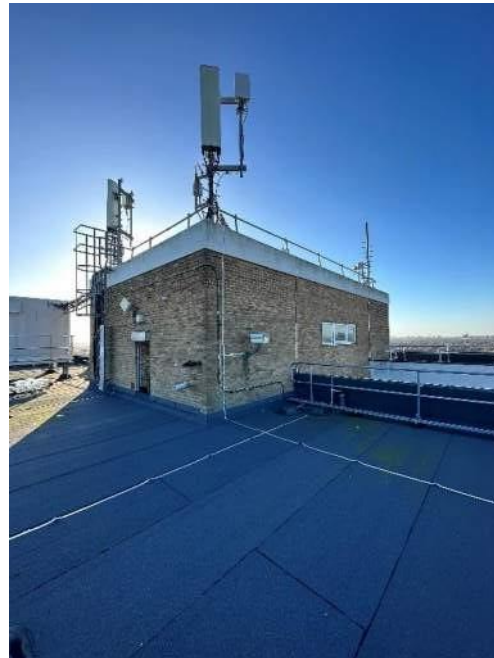
Figure 14 and 15: Roof Level

There were no tell-tale signs of any significant structural movement noted at the time of our inspection.

The exterior walls were noted to be plumb with no signs of significant bowing, bulging or leaning noted to the cavity wall panels.

The roof has a felted finish. The exact build-up of the roof finishes were not accessible at the time of inspection. It is recommended an intrusive survey of the roof finishes is completed by a specialist surveyor to assess the condition of the roof covering.

A plant room likely for telecommunications equipment has been installed to the roof level off a steel subframe. No calculations were provided for this, we can only presume that the slab was checked for the additional point loads added to the structure.

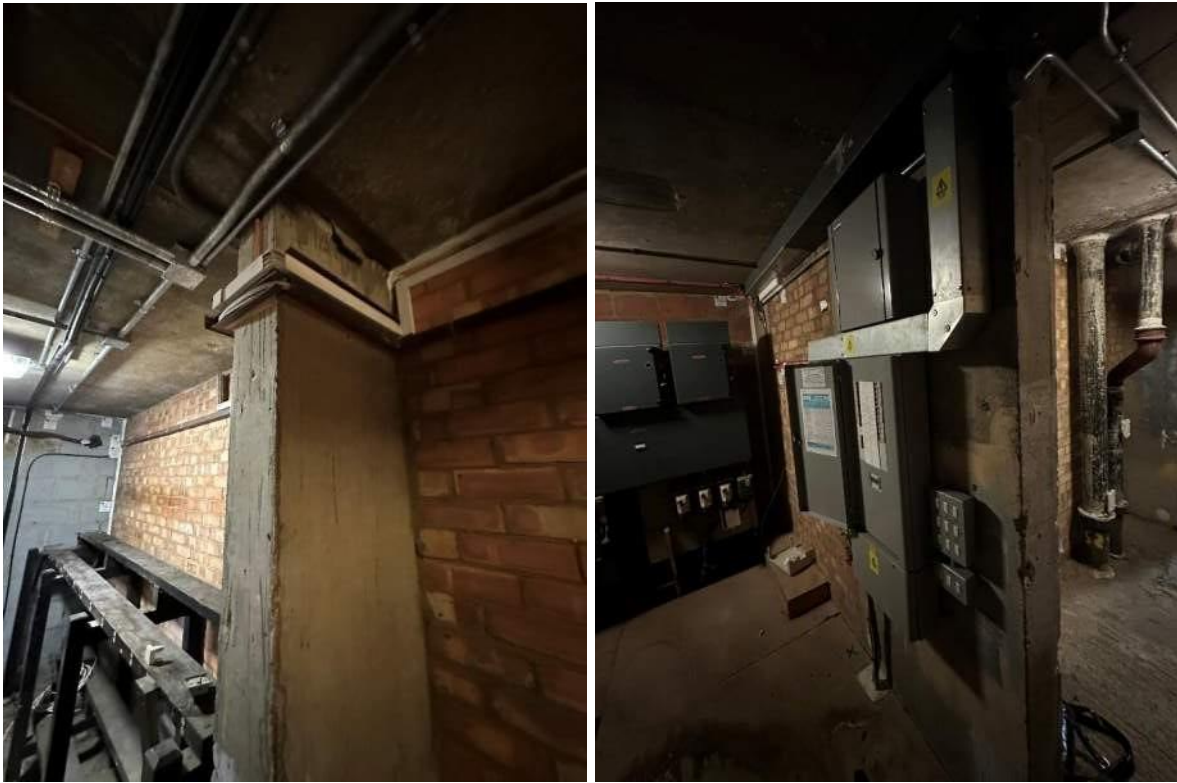
The floors in the communal landings were noted to be solid concrete floors. The floors were checked with a spirit level and were considered level and within tolerance. The doors and windows to the communal landings from the stair core all appeared to be level and opened and closed without difficulty. There were no signs of structural movement detected.

There were vertical concrete walls supporting the floor plates at every level.

The interior of the stair core walls were checked and were plumb and in line with observations made to the exterior – no significant signs of leaning or movement noted. The concrete appeared in fair condition with few BRE category 1 cracks but no structurally significant defects were noted.

Figure 16 and 17: Vertical RC Structure Visible with RC soffit

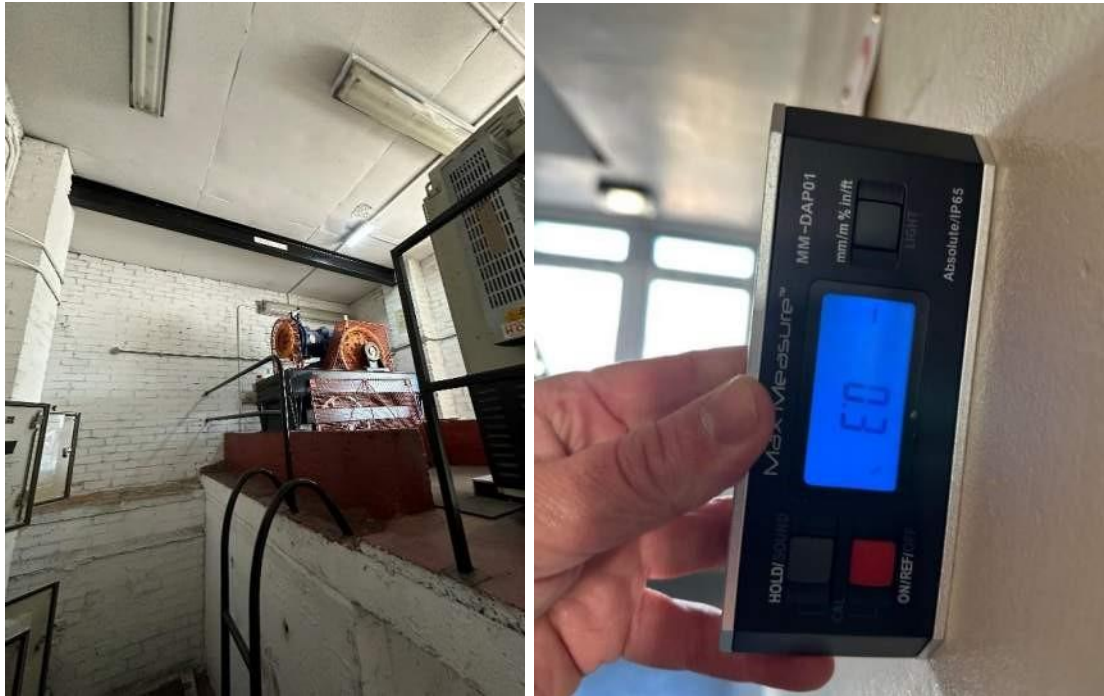
Figure 18 and 19: Lift motor room and level of vertical element

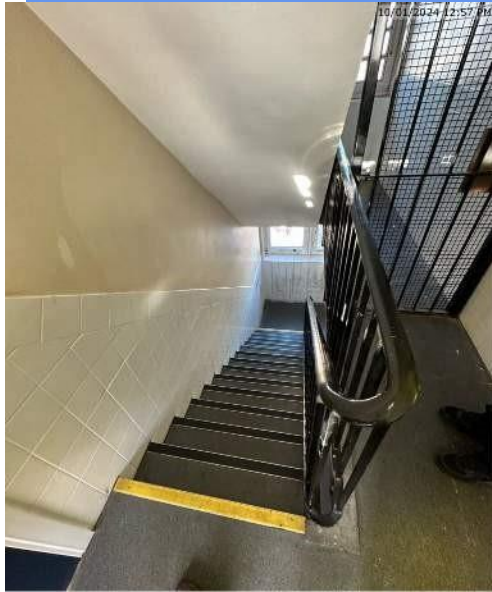
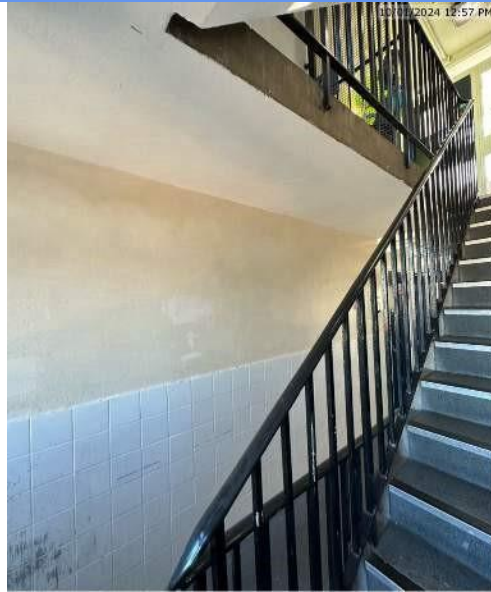
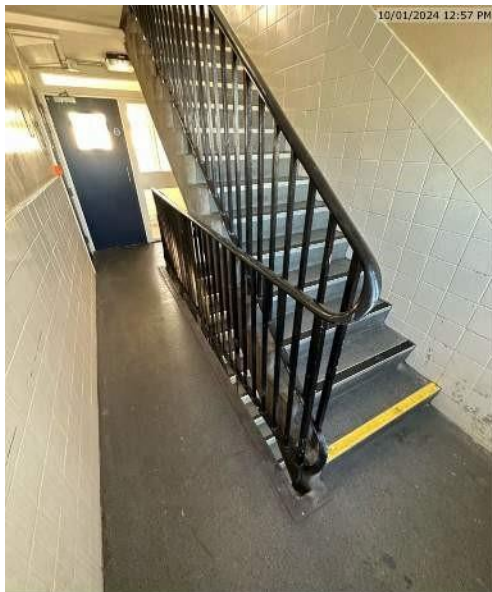
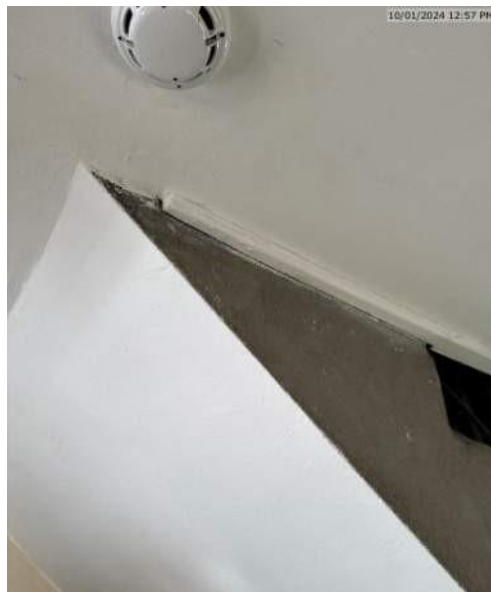
Reference: Internal
Location: 16th Floor
Created: 10/01/2024
Description: Photographs indicating stairwell area. Photographs also indicate floor slab thickness and stair stringer thickness.
Assigned To: Internal finishes
Reviewed By: Ruben Wood

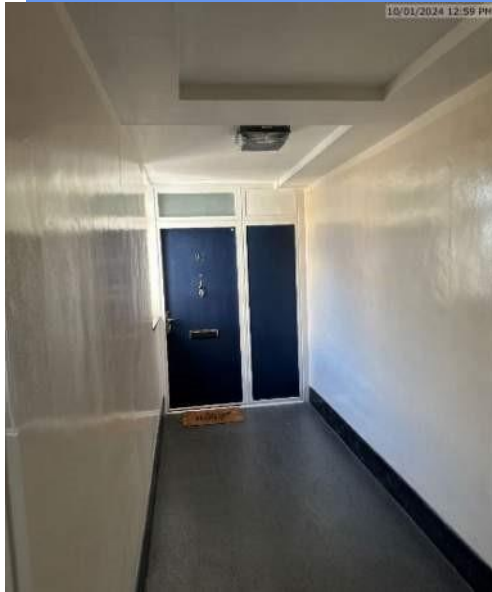
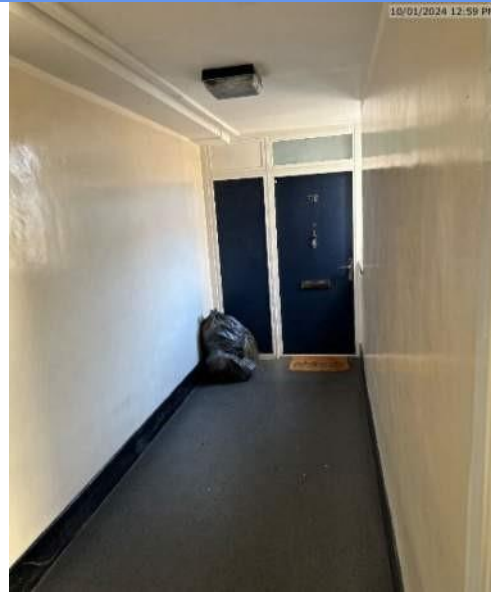
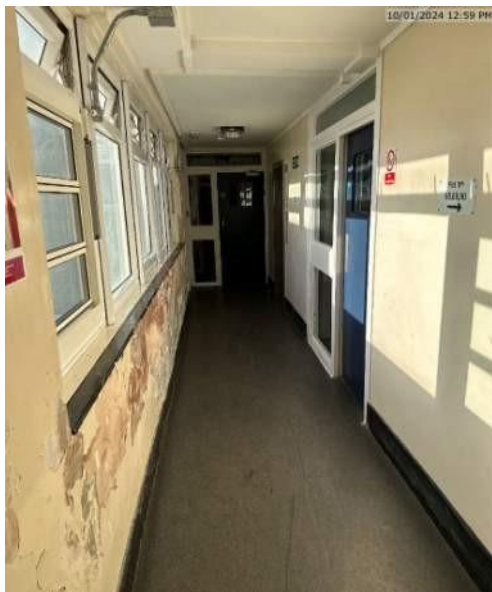
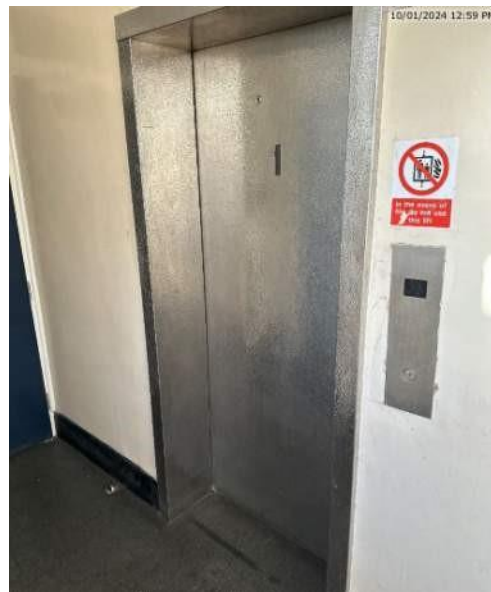
Reference: Internal
Location: 16th Floor
Created: 10/01/2024
Description: Photographs indicating corridor forming access to flats and lift shaft. Please note all access doors open and close with ease with no binding. Photos also indicate external elements of the building.
Assigned To: Internal finishes
Reviewed By: Ruben Wood

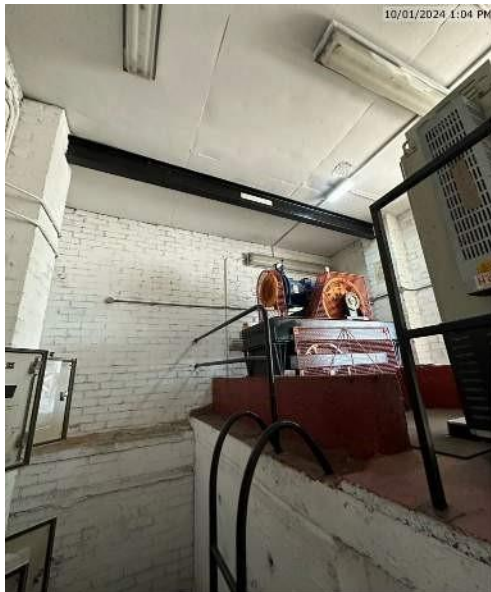
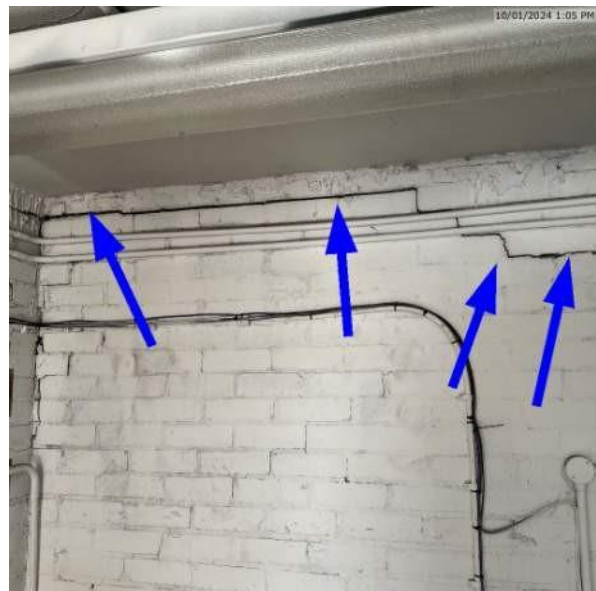
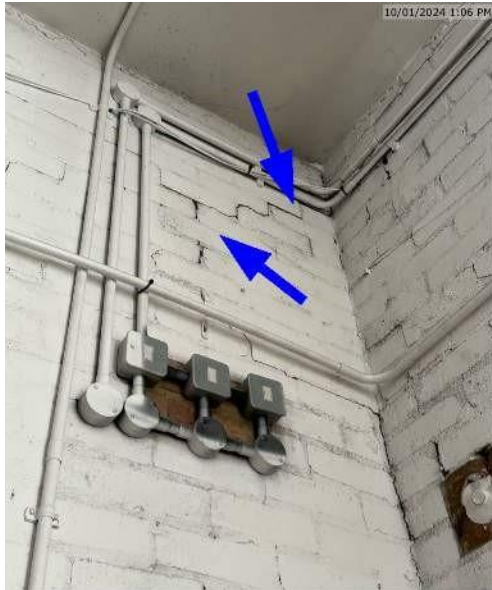
Reference: Internal
Location: Internal roof level
Created: 29/11/2023
Description: Photographs indicating internal plant room which houses the motors for the lift shafts. Please note walls consist of a brick finish with concrete sections also. Please note the floor consist of a concrete finish and also the ceiling. Please note the steel beams at ceiling level supported on brick piers. There are open joints to the brickwork and this occurs between the first and second course at ceiling level.
Assigned To: Internal finishes
Reviewed By: Ruben Wood

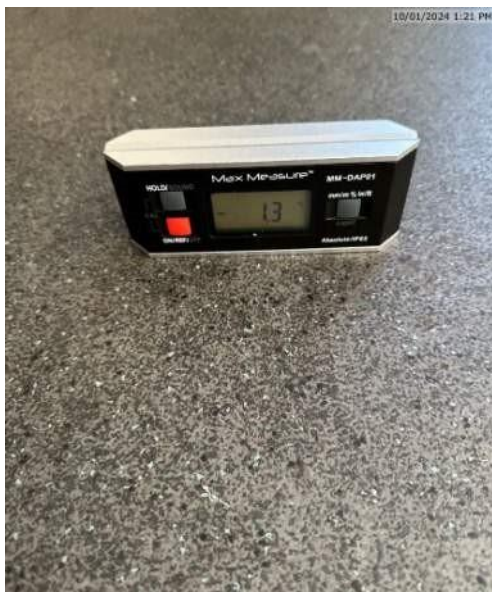
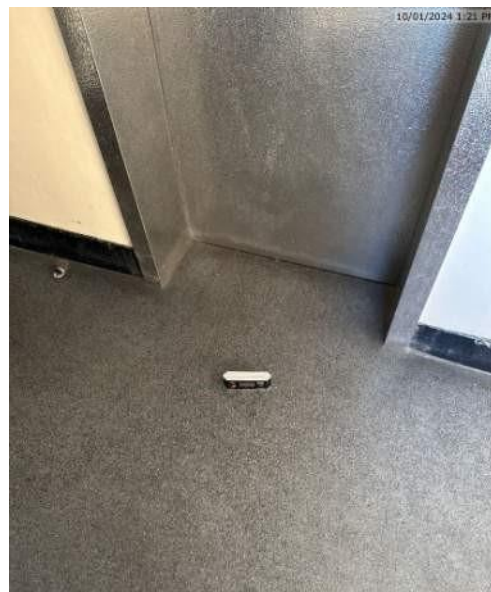
Reference: Internal
Location: 8th Floor
Created: 10/01/2024

Description: Photographs indicating finish floor levels to lift shaft area.
Assigned To: Internal finishes
Reviewed By: Ruben Wood

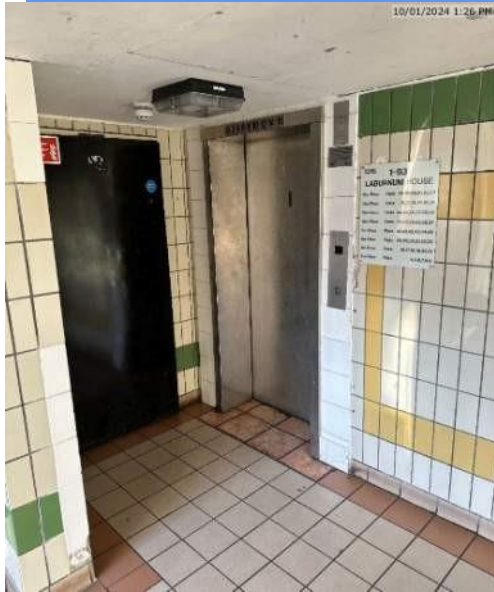
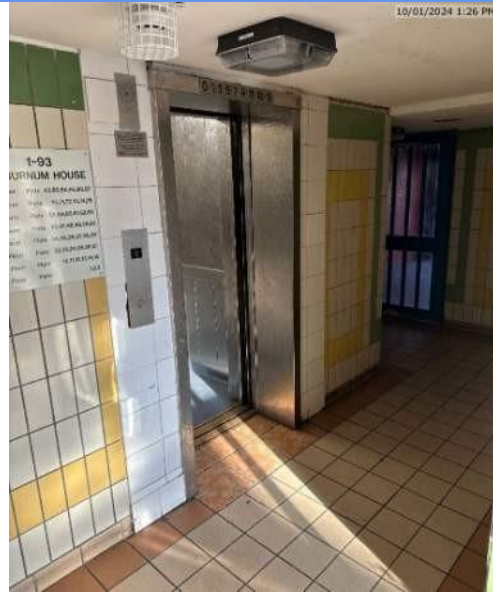
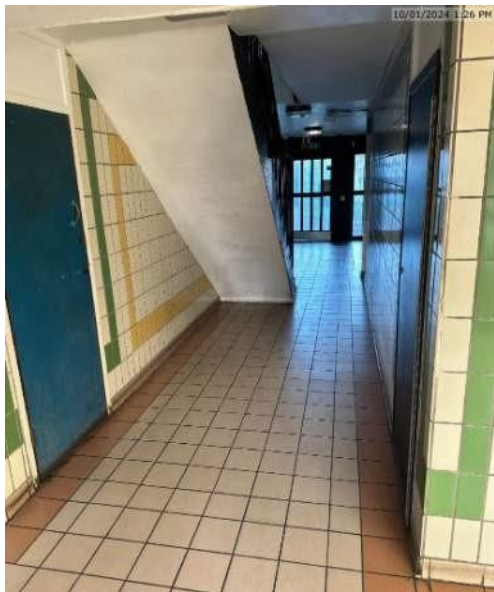
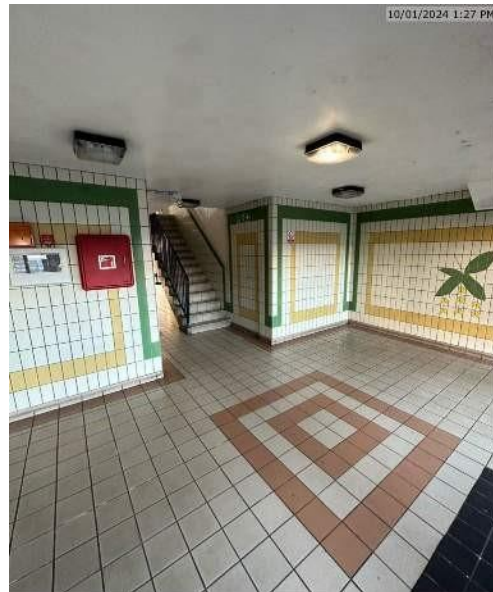
Reference: Internal
Location: Ground floor
Created: 10/01/2024
Description: Photographs indicating internal lobby/ entrance area with access to lift shafts.
Assigned To: Internal finishes
Reviewed By: Ruben Wood

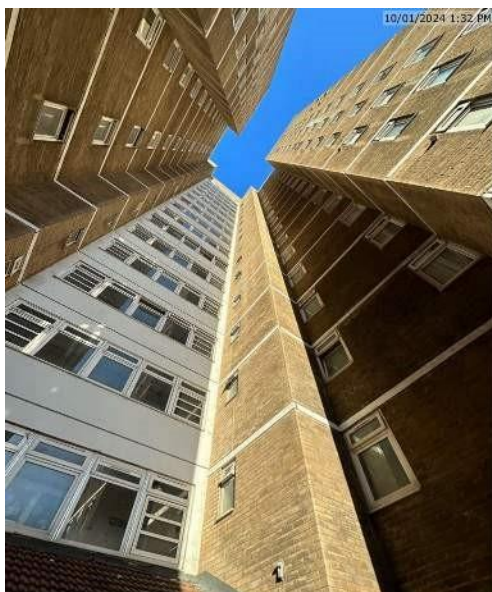
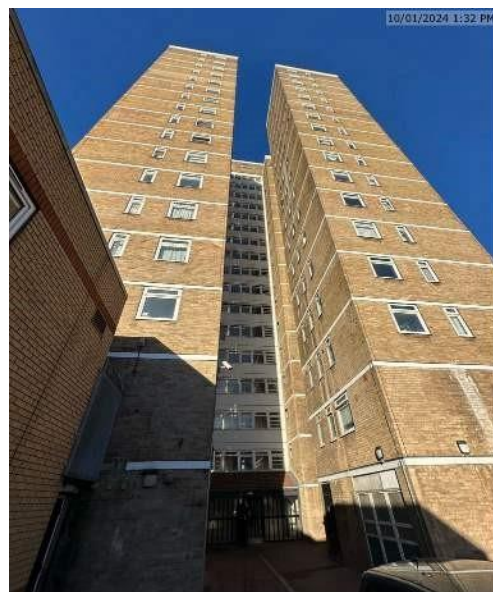
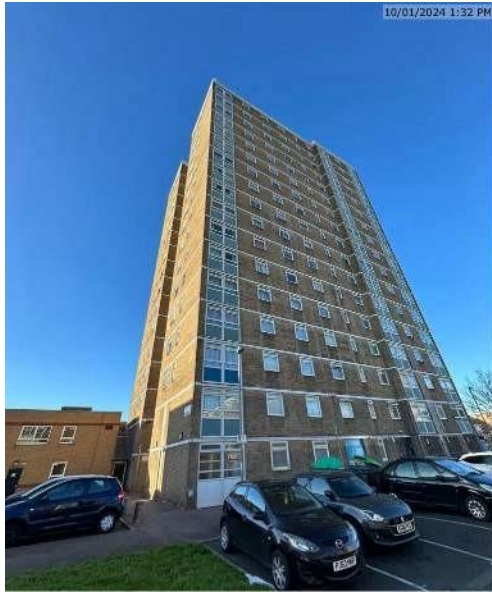
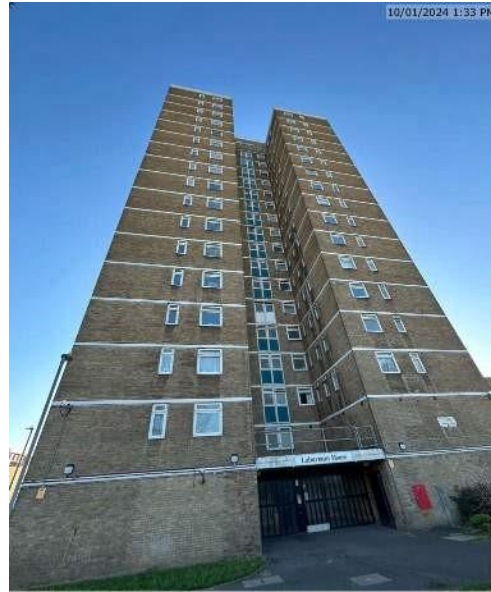
Reference: External
Location: External
Created: 10/01/2024
Description: Photographs indicating external elevations and elements of the building.
Assigned To: External elements
Reviewed By: Ruben Wood
