PAS 9980 STEP 1 LABURNUM HOUSE

Laburnum House
89 Bradwell Avenue
Dagenham
London
RM10 7AE

PAS 9980 Step 1

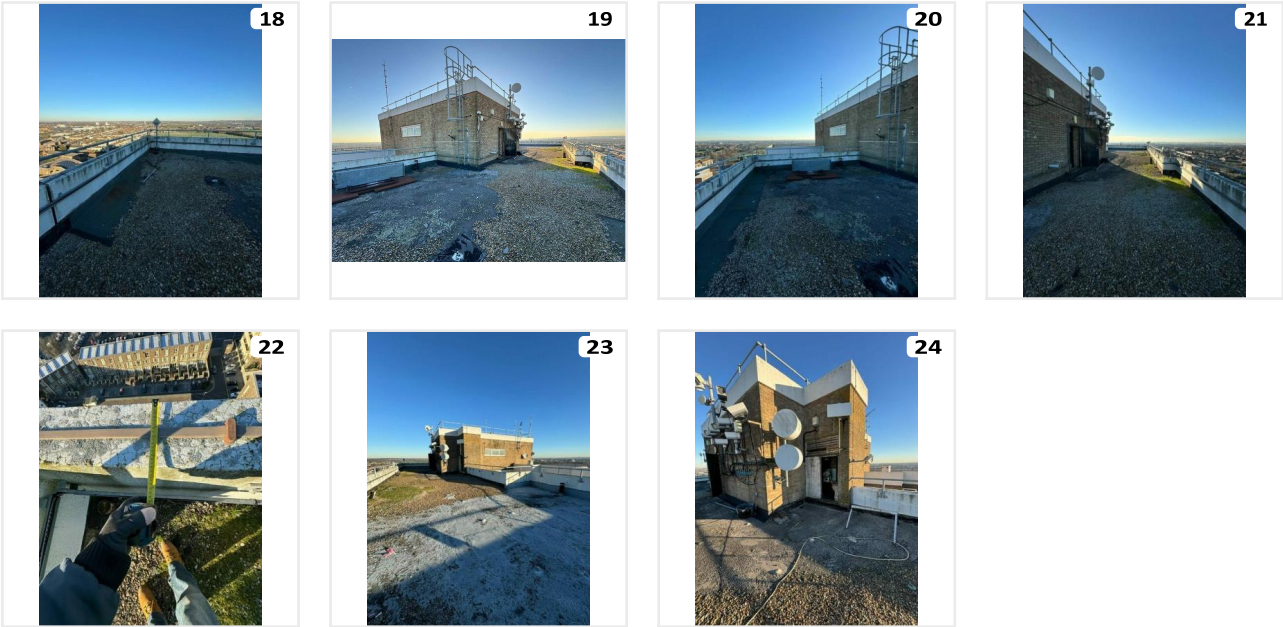
Inspection: VK54AF

1 Element	Thickness/Depth	Material	Photo Ref.	Rating (BS EN13501)
Surface Finish	180mm	Reinforced concrete	18, 19, 20, 21, 22, 23, 24	A1 - Non-Combustible

Reinforced concrete upstand

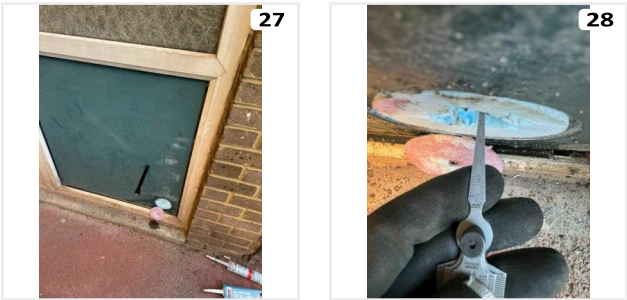
Inspection: VKCB7Q

Surface Finish	1mm	Sheet Metal	27	A1 - Non-Combustible
Insulation	30mm	XPS Insulation	28	C - Combustible
3 Elements	Thickness/Depth	Material	Photo Ref.	Rating (BS EN13501)
Expanded polystyrene board				
Inner Leaf	1mm	Sheet Metal		A1 - Non-Combustible
