Document Version 1  
Survey Date 10/02/2024  
Suggested Review Date 10/02/2025

# PAS 9980 STEP 2-5 (FRAEW) LABURNUM HOUSE

Laburnum House  
89 Bradwell Avenue  
Dagenham  
London  
RM10 7AE

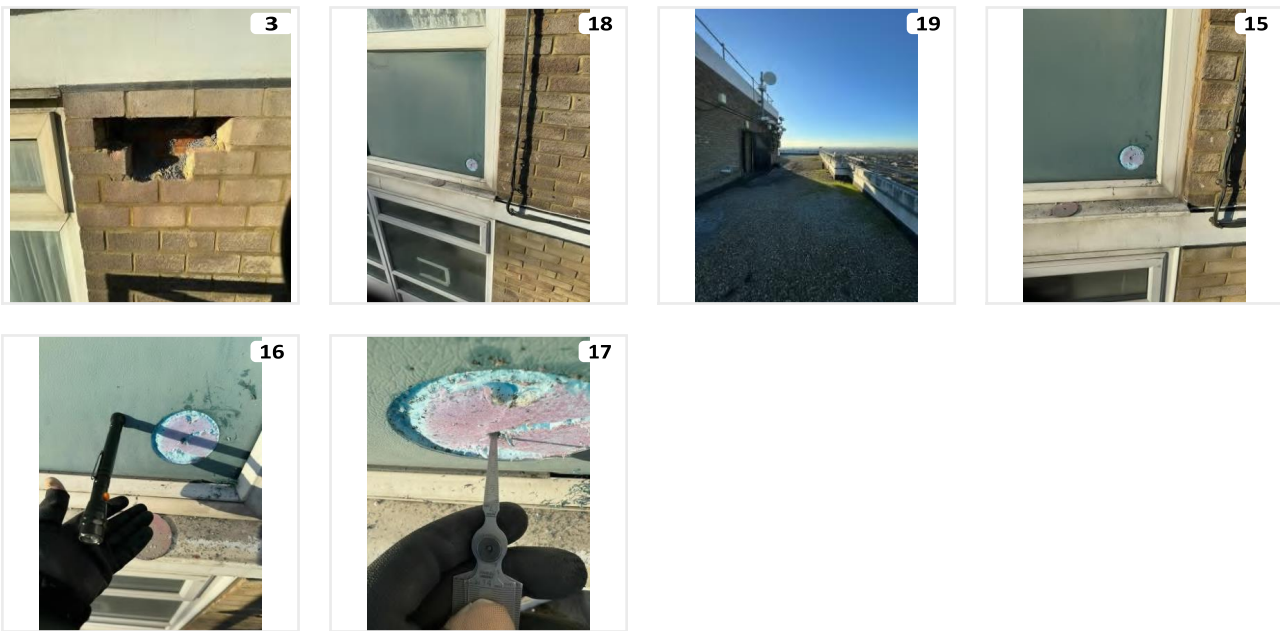
Information on window configuration is not provided with the exception of infill panels. Therefore the frames are assumed to be of steel construction in line with infill panels
