Risk Assessment for Legionella Control at Laburnum House 1-93

Laburnum House 1-93

13/06/2024

REF NO: 1410265

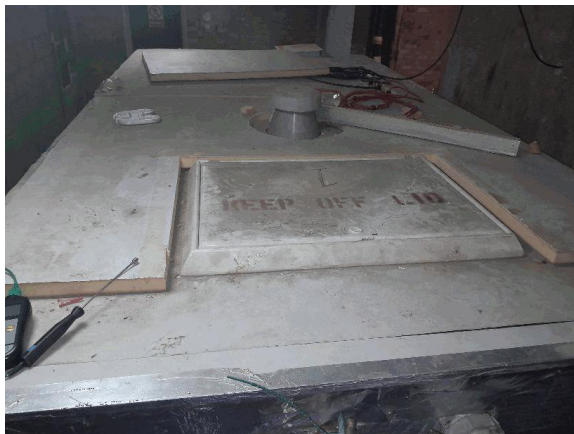
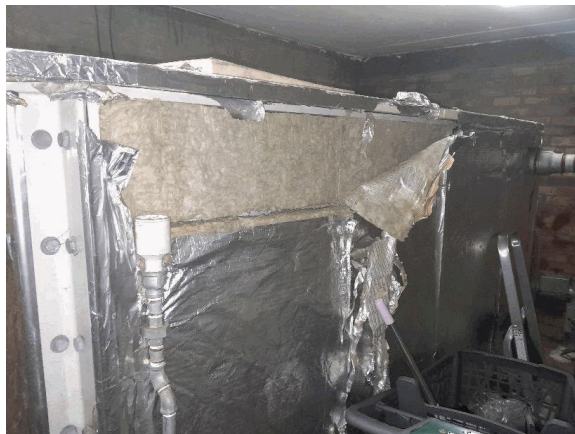
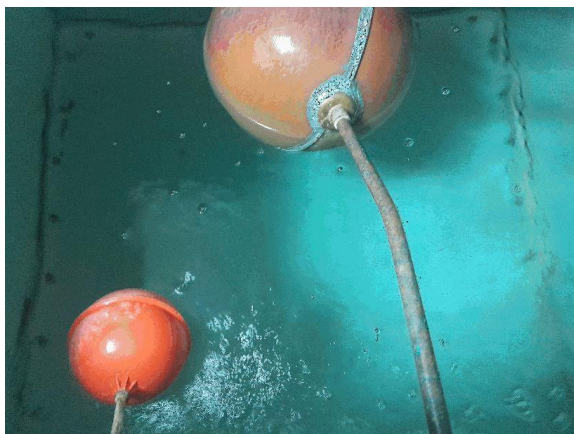
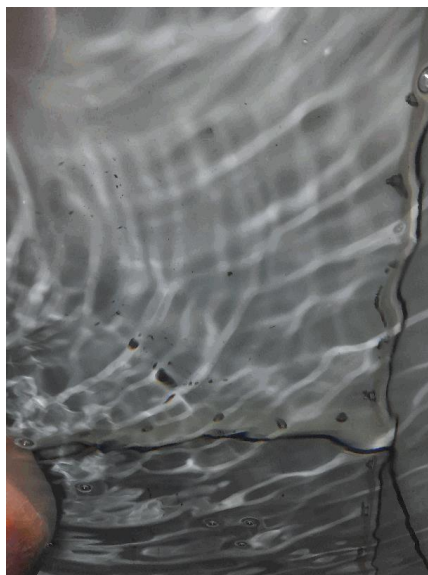
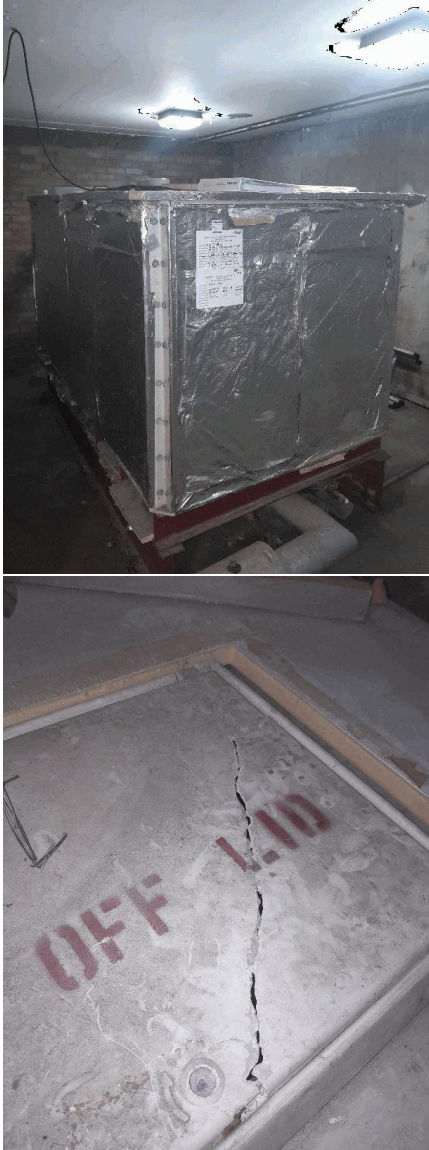
Lid torn.

Outlet 002 is used as a drain valve - recommend regular flushing

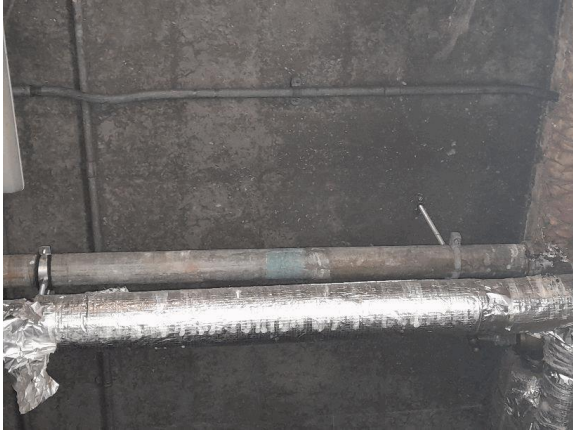
Inlet pipe with partial insulation

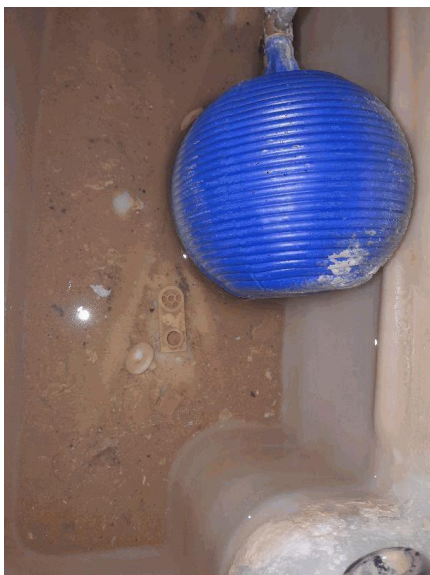
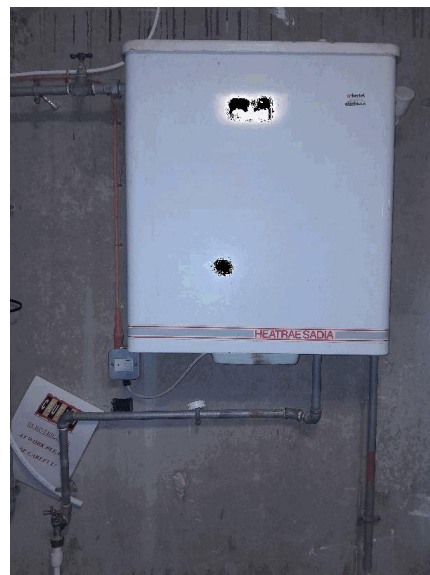
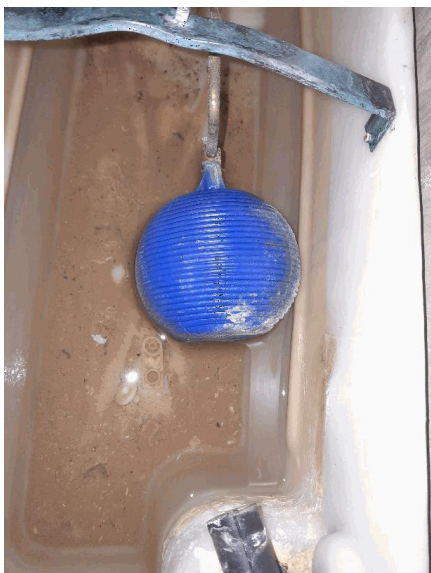
Observation	Recommendation	Compliance rating
Hot water generator supply pipework not insulated	Insulate supply pipework	Medium Risk

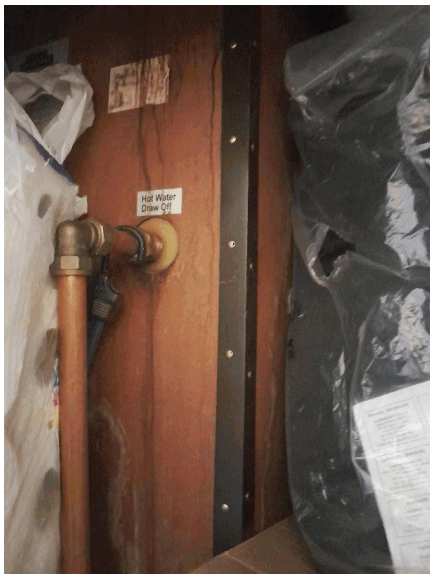
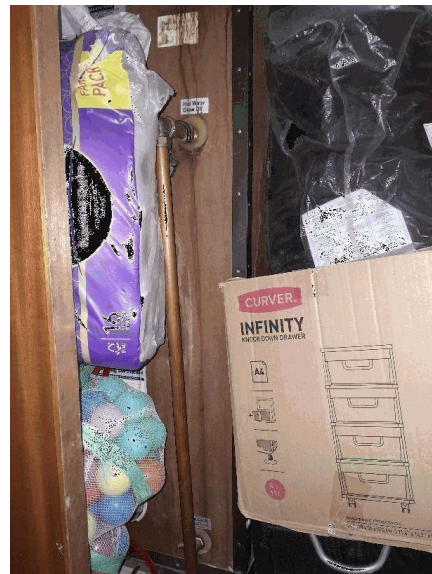
No access to cws as it is behind wooden pannel.

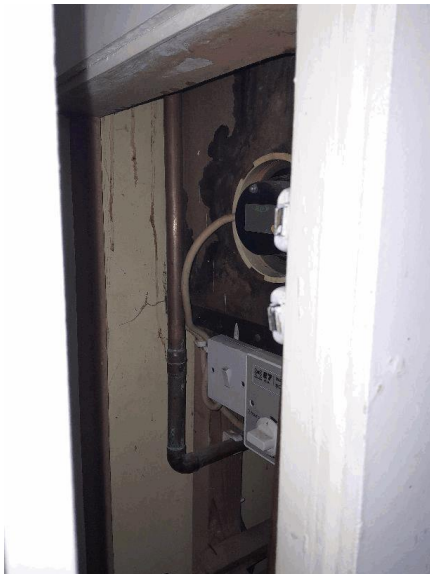
Only bottom halve of HWS accessible.

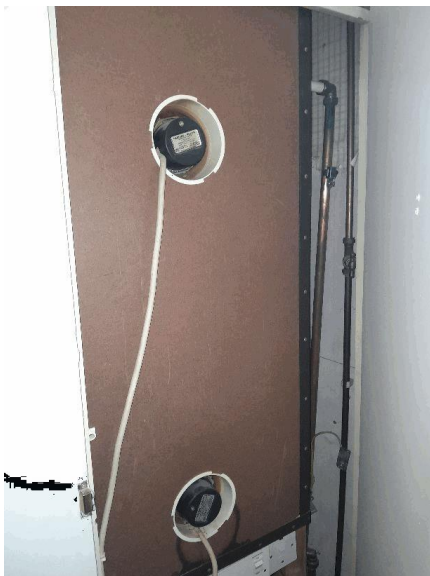
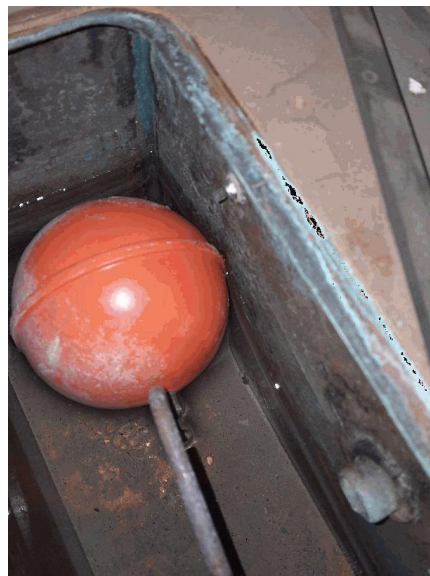
No access to cws.

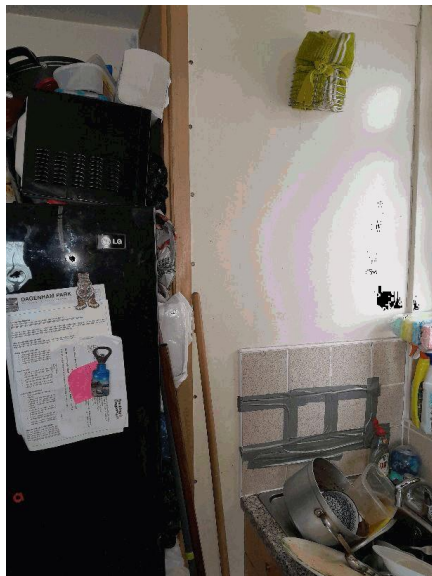
No access to HWS/CWS
