PART B: CONSERVATION AREA MANAGEMENT PLAN

6.0 ISSUES AND OPPORTUNITIES

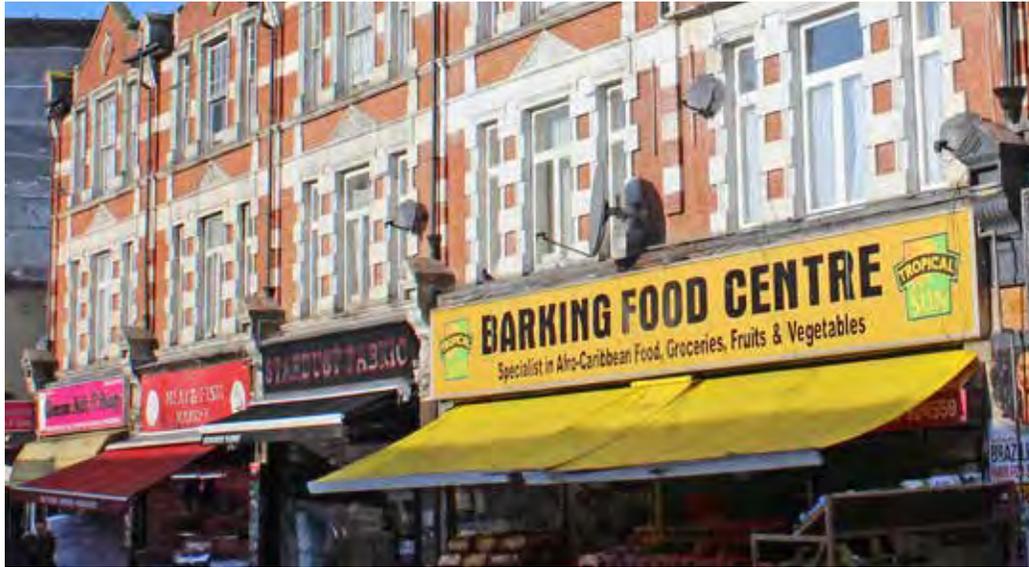
Satellite dishes attached to principal elevations of buildings in the conservation area.

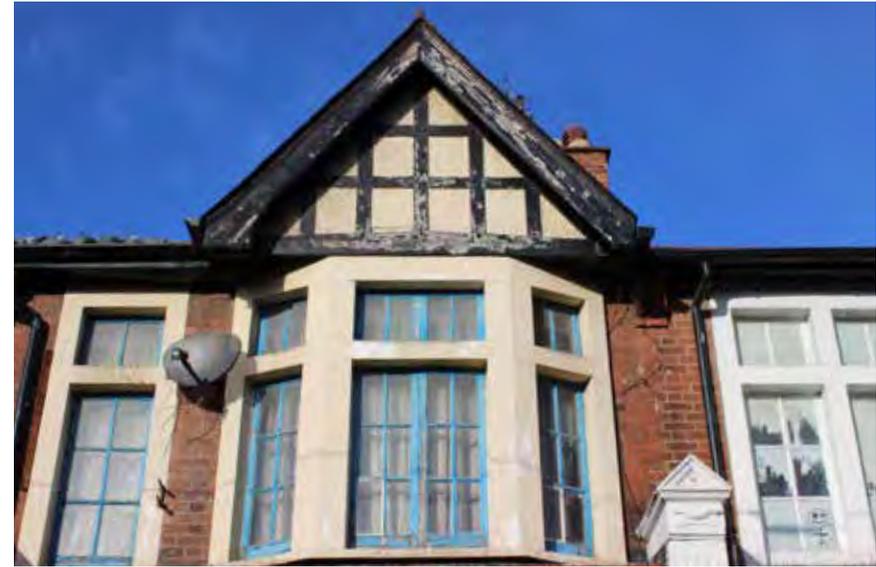
This building has peeling paintwork to both the gable and windows, exposed wiring and a satellite dish, all of which detract from the appearance of the conservation area.

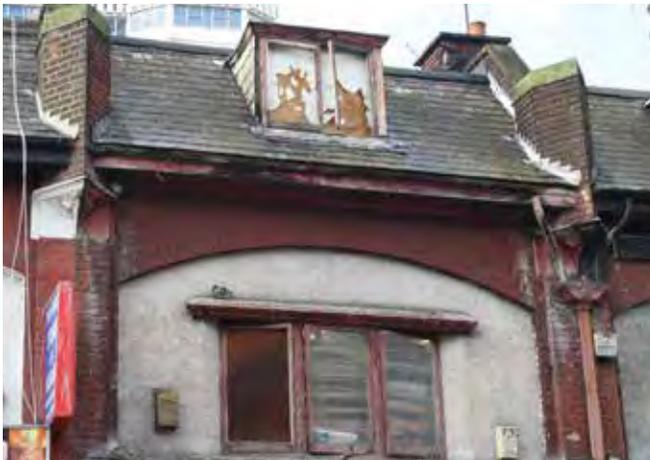
This building is in an extremely dilapidated condition due to lack of maintenance.

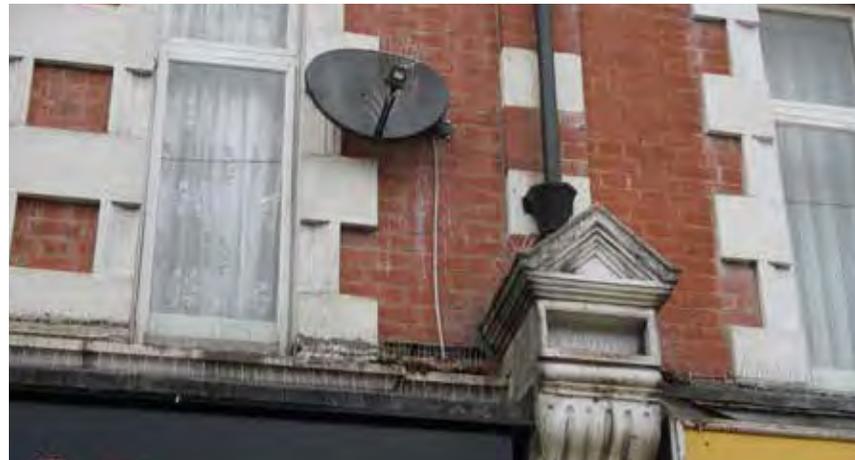
Pigeon spikes are used extensively in the conservation area, they detract from the conservation area and are also appear to be ineffective.

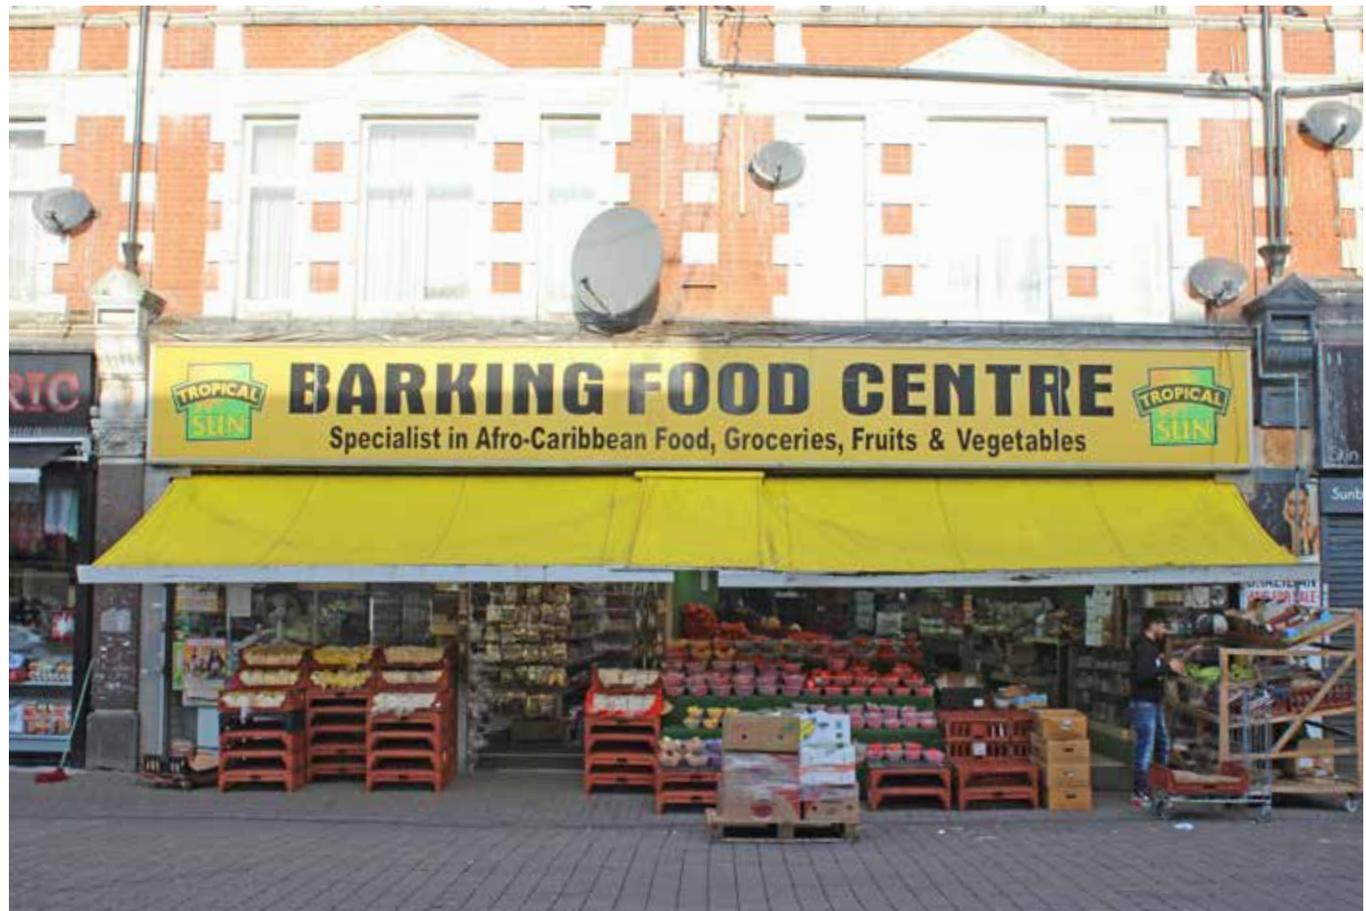
This shopfront has been extended across two historic units with the pilaster and corbel which would have separated them lost. The frontage also has inappropriate internally lit fascia signage and a poorly positioned and dilapidated canopy.

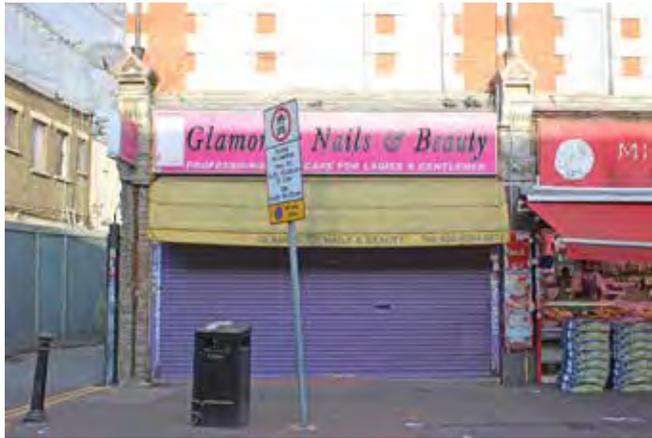
The scale, material and internally lit nature of this shop signage, both projecting and fascia, is inappropriate within the conservation area. Dutch-style canopy is inappropriate as it remains visible when retracted. The canopy is poorly positioned below the signage and is dilapidated. This shop front also has a roller shutter which also detracts.

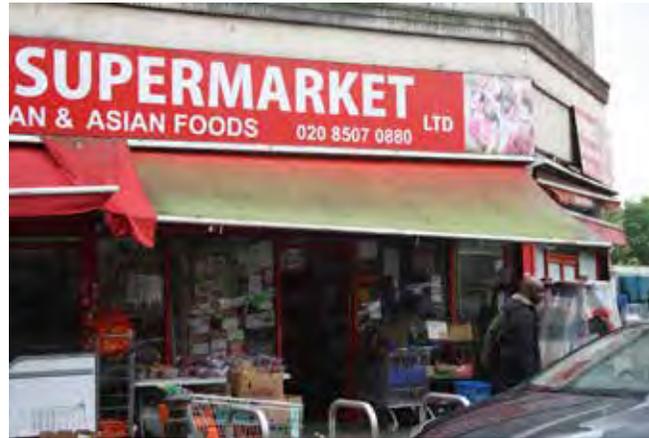
The inappropriate signage and canopy above modern metal shop frontage detracts from the appearance of the building and the conservation area more widely.

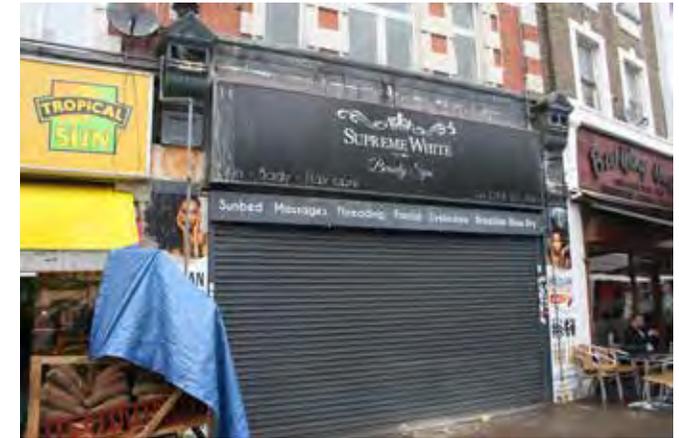
A shop in a dilapidated condition and with inappropriate fascia sign and metal roller shutter.

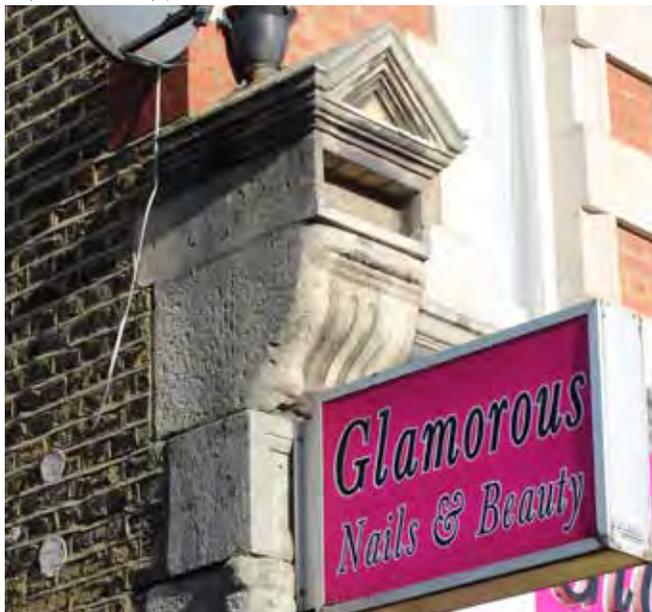
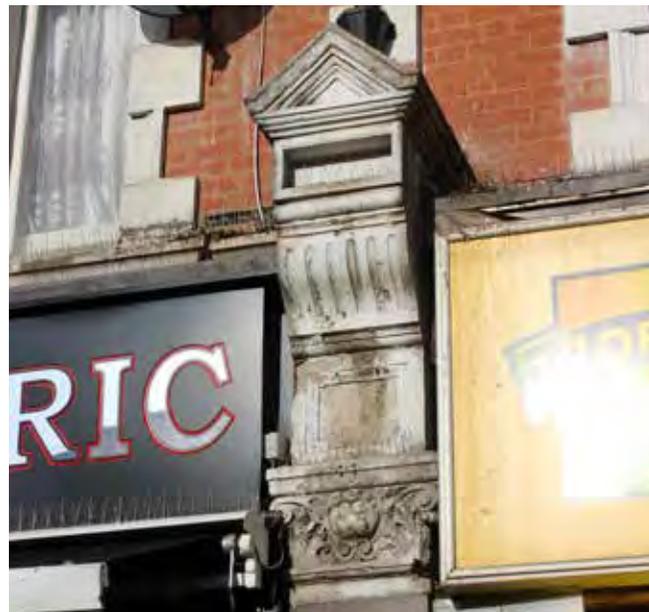
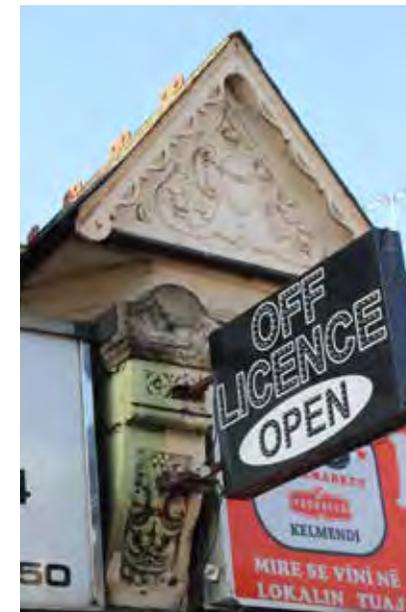
Surviving but damaged historic shopfront corbels often with inappropriately attached projecting signs and pigeon spikes.

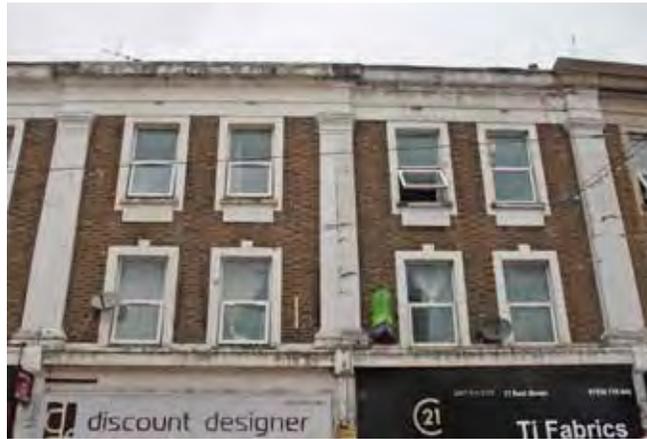
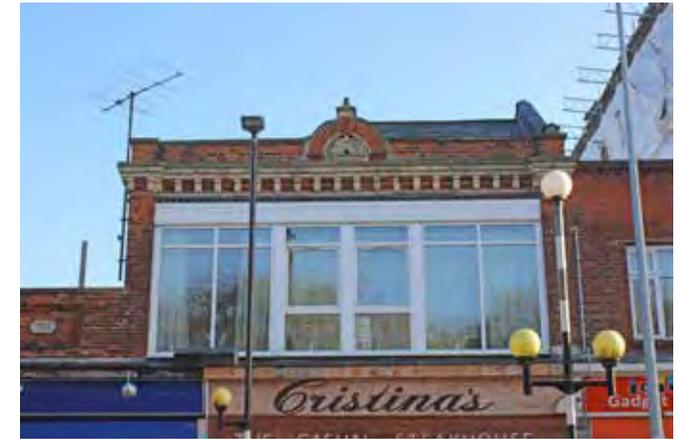
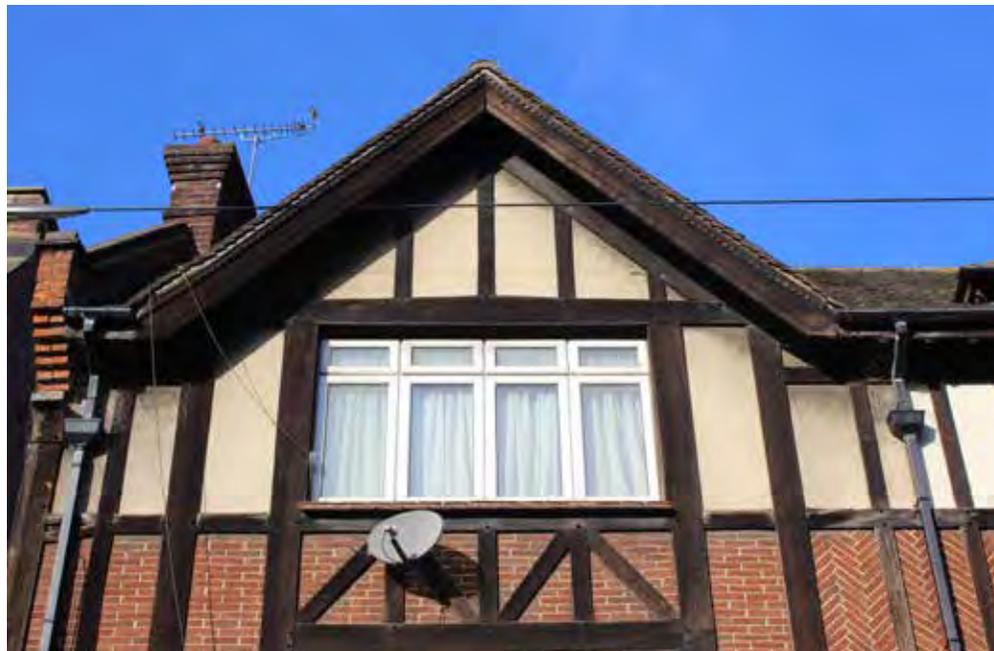
In insensitive replacement of traditional windows with uPVC units is harming the appearance of the conservation area.

There are opportunities to improve the appearance and the condition of the built fabric of the conservation area by returning uPVC windows and doors back to traditional timber units. Future change of traditional timber windows to uPVC would be resisted.

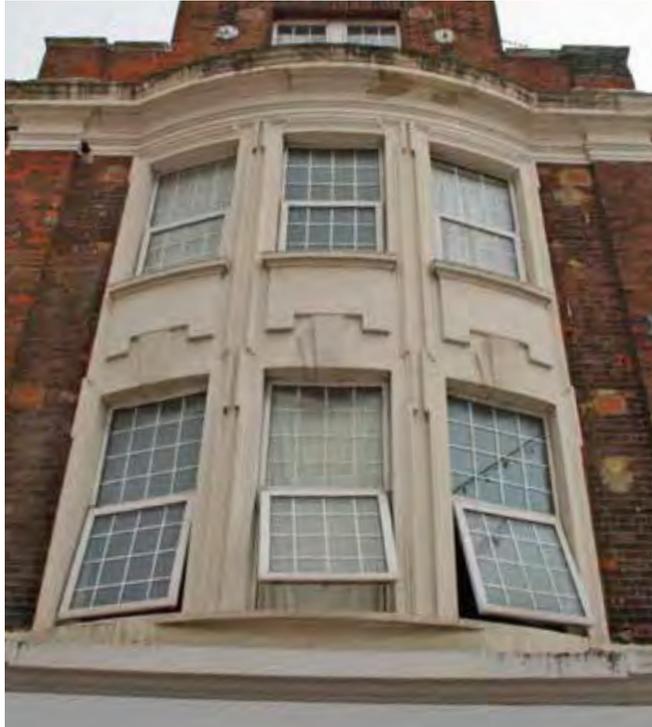
Inensitive replacement of traditional windows with uPVC units is harming the appearance of the conservation area.

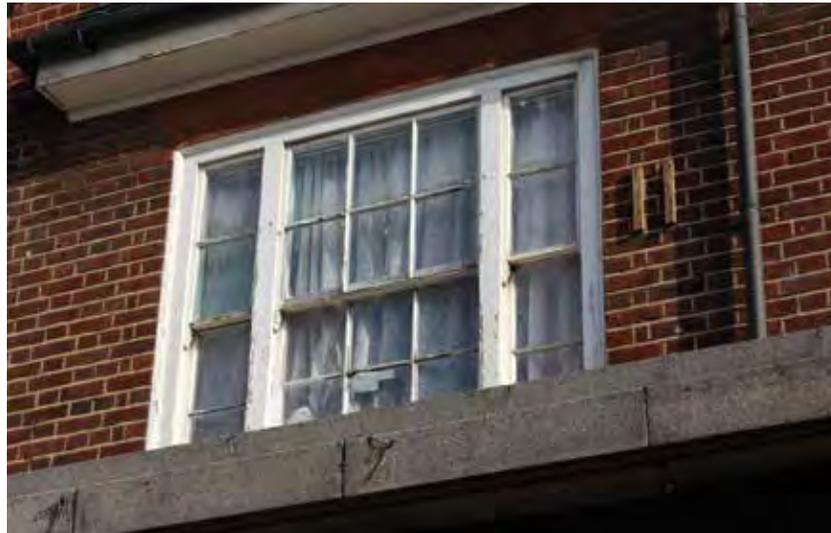
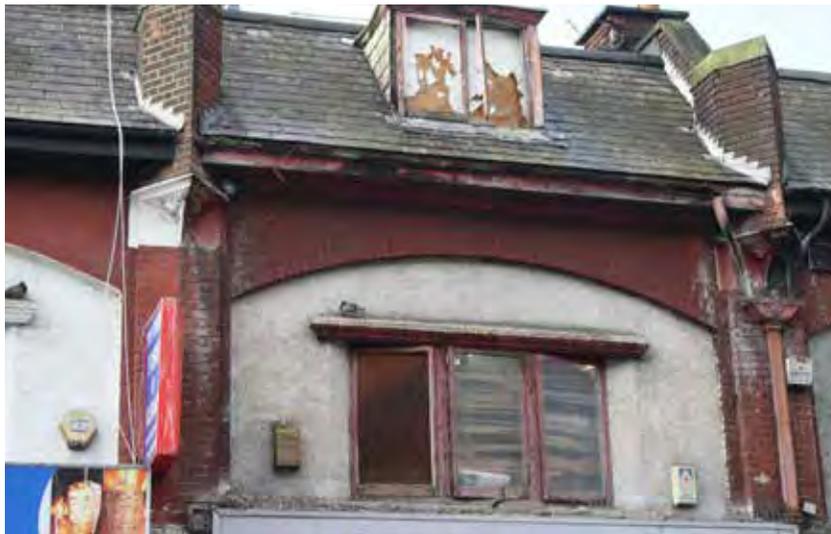
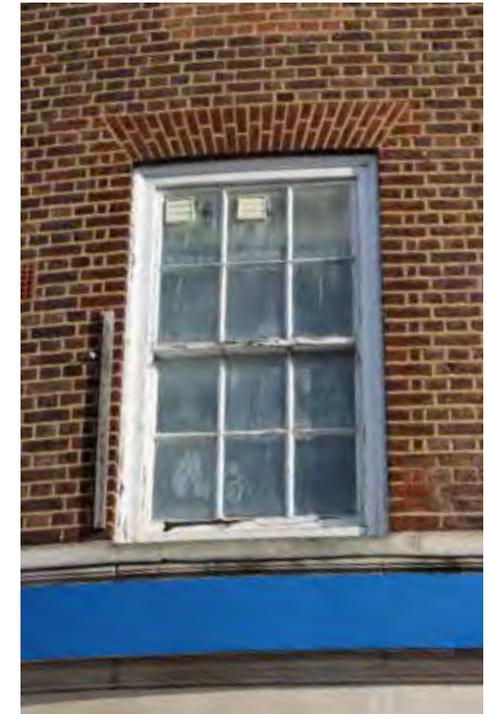
Many of the surviving timber windows are in a poor condition from neglect and lack of maintenance

Some of the windows in historic buildings have not been replaced. However, almost all cases the windows have been neglected and are poorly maintained. They are therefore degraded to varying degrees. Regular maintenance and, where necessary repair, of these historic windows would both improve the appearance of the conservation area and also allow the historic fabric to survive longer.

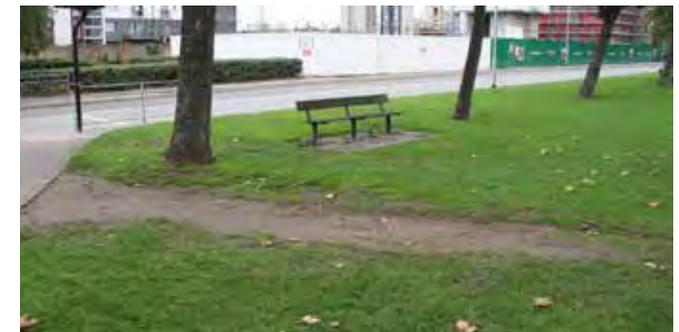
Erosion to the grass at the edge of the park, the footpaths should be reviewed to ensure their alignment is correct.

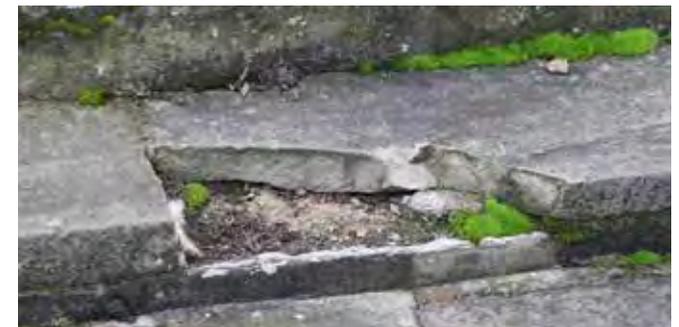
Damage to steps in the Abbey remains; the steps are made from former gravestones.

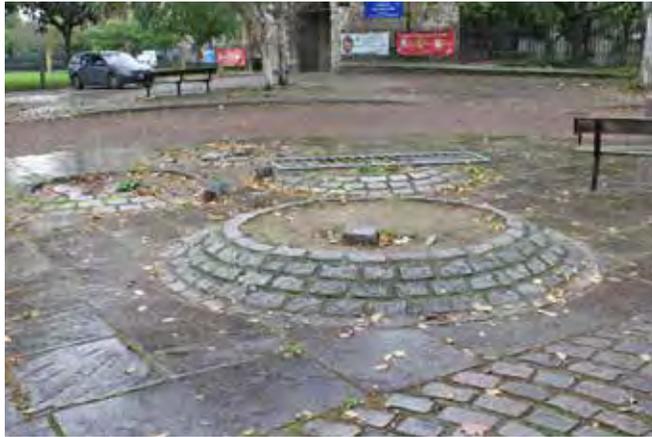
Damage to the granite setts in front of the Curfew Tower and loss of the feature trees.

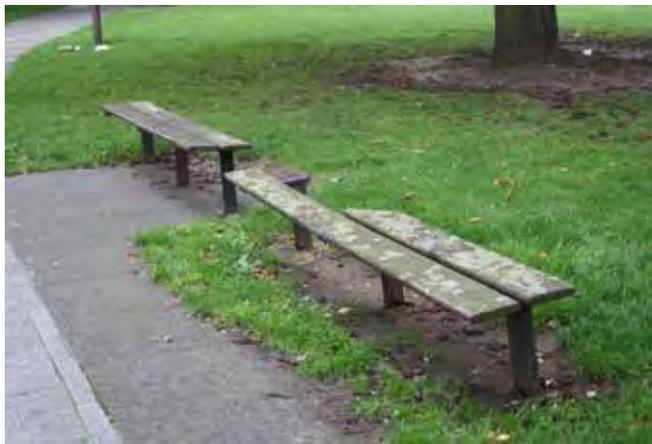
Dilapidated seating in Abbey Green.

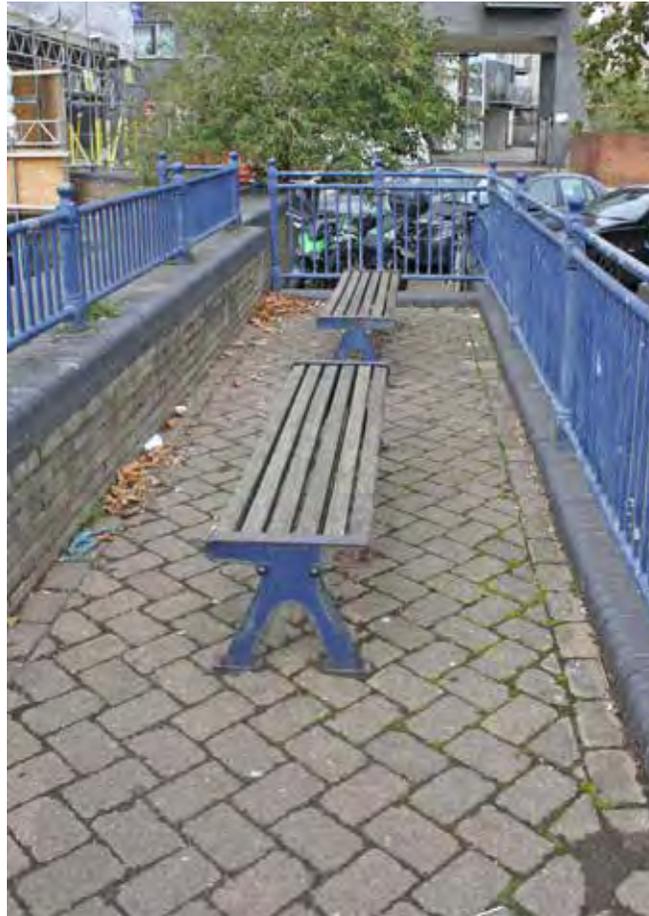
Outdated and neglected public realm around the Town Quay.

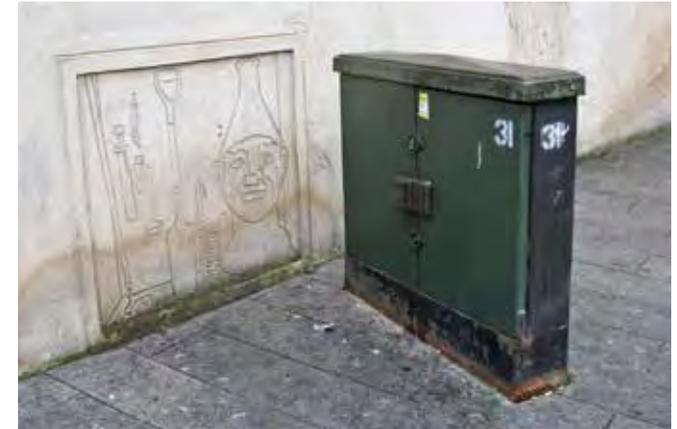
A very poorly positioned broadband cabinet.

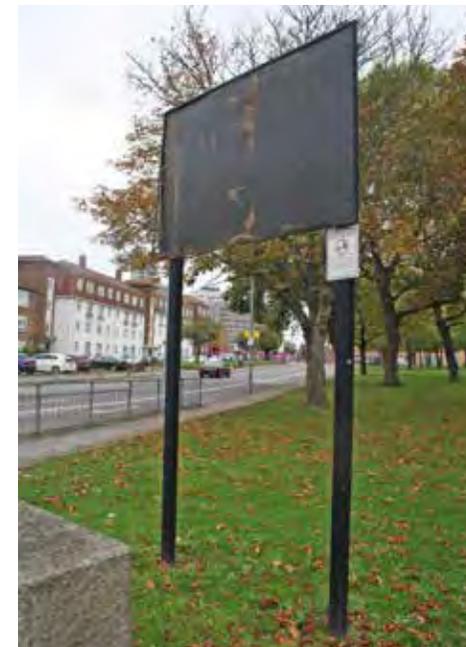
Redundant signage in Abbey Green.

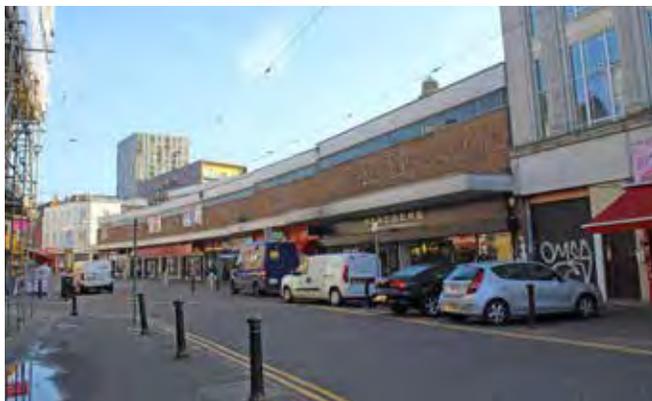
East Street detracts from the conservation area primarily due to the building's horizontal appearance and lack of an active frontage on the upper floors.

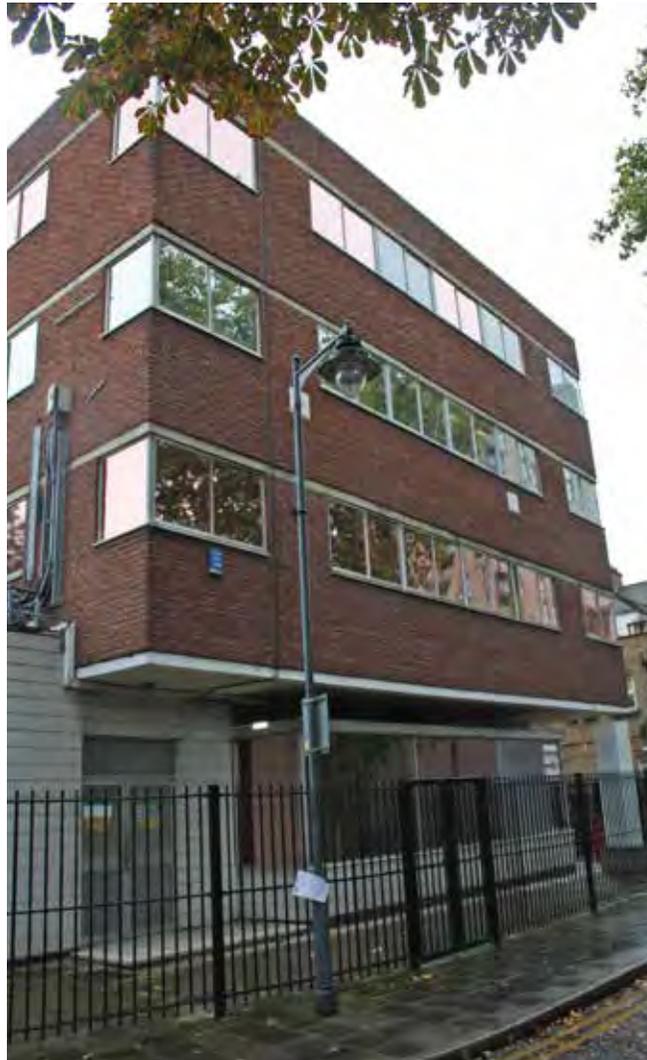
Glebe House on Vicarage Drive detracts from the conservation area due to its insensitive massing and appearance.

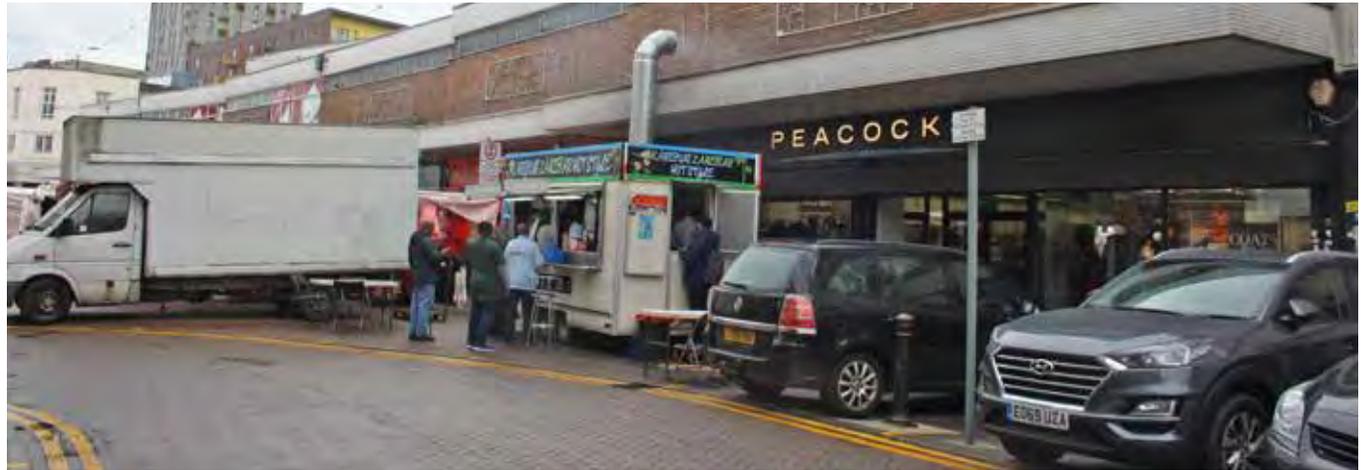
Cars parked illegally along the pedestrianised East Street.

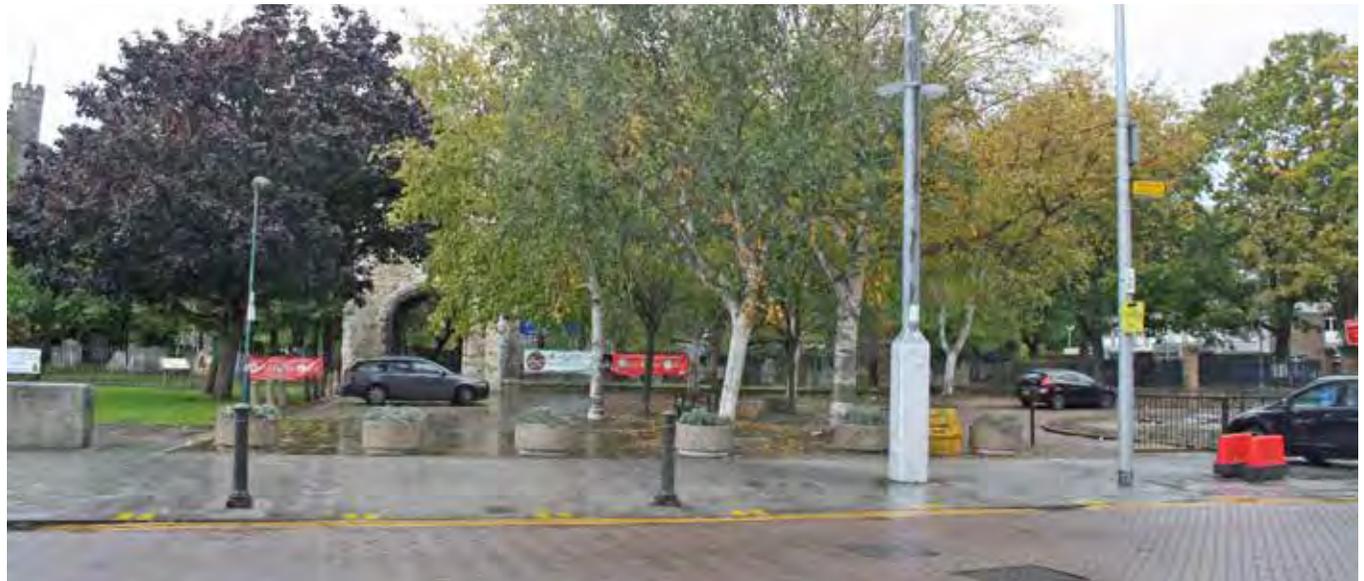
Cars parked on the public realm in front of the Curfew Tower.
