# Fire Risk Assessment

1-93 Laburnum House - Dagenham - RM10 7AE - 900042519

20 Feb 2025

Chris Daly BEng(Hons) MIFSM

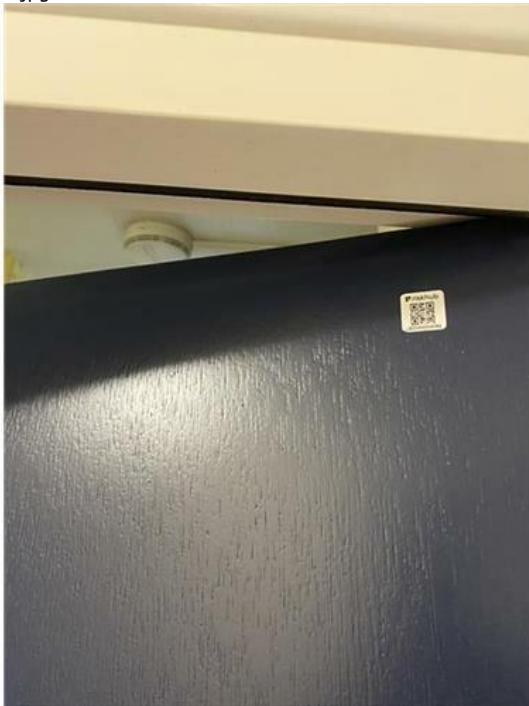
IMG\_7042.jpg

Ref	Sub Section	Question	Non-conformity	Recommendation	Location	Who is responsible	By When
13422319	5.0.K	Do the fire resisting door sets meet the appropriate standard?	The fire door requires a selfclosing device. Tenant advised to remove existing overhead self closing device by LBBD.	The fire door indicated must be fitted with a suitable positive action self-closing device (BS EN 1154).	Front Door to Flat 29	Statutory requirement for the Client	09/04/2025

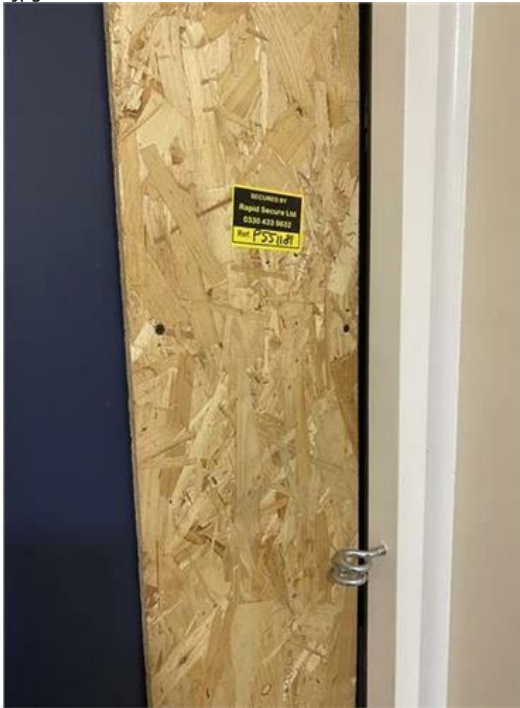
IMG\_7045.jpg

Ref	Sub Section	Question	Non-conformity	Recommendation	Location	Who is responsible	By When
13422318	5.0.V	Do the fire resisting door sets meet the appropriate standard?	The existing fire door is damaged compromising the fire resistance provided by the door sets.	The damaged fire door must be repaired or replaced to ensure that the required level of fire resistance is maintained.	Front Door to Flat 22	Statutory requirement for the Client	09/04/2025

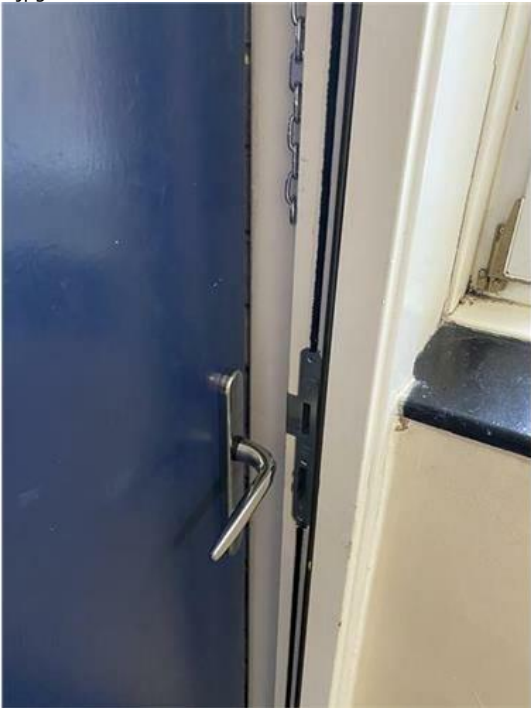
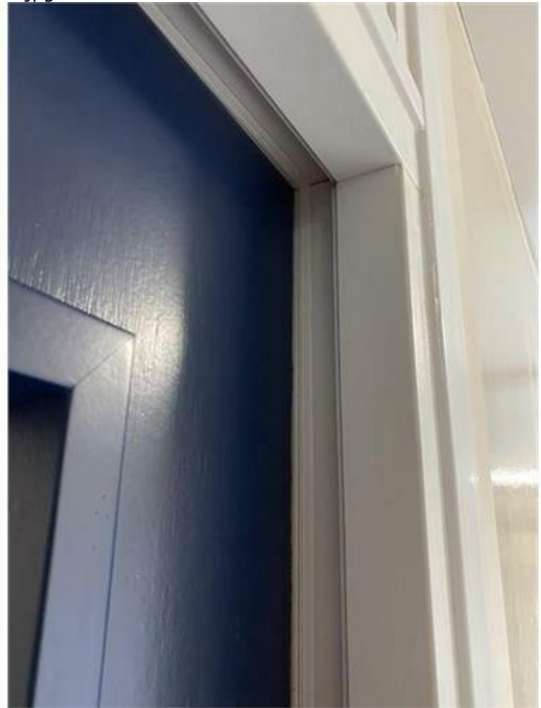
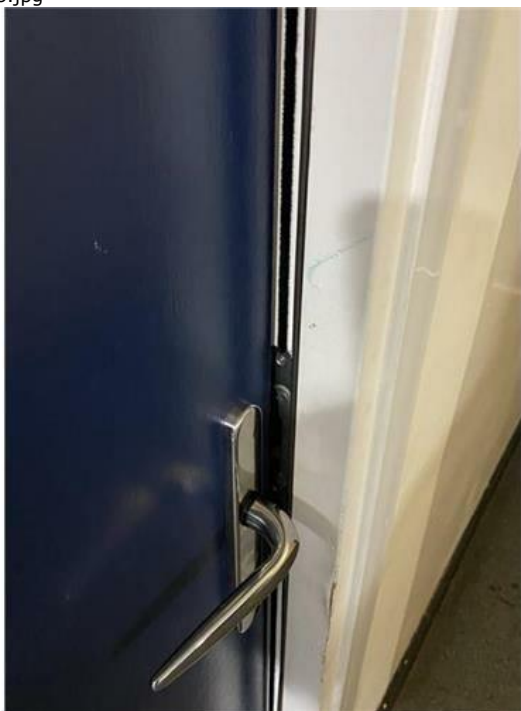
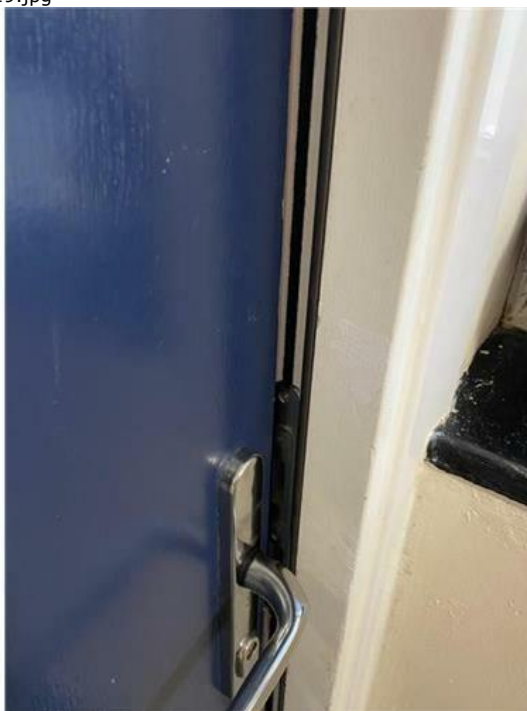
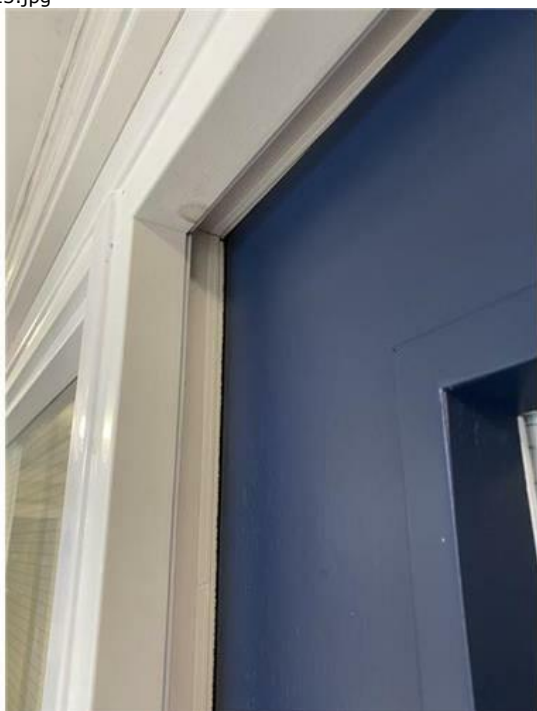
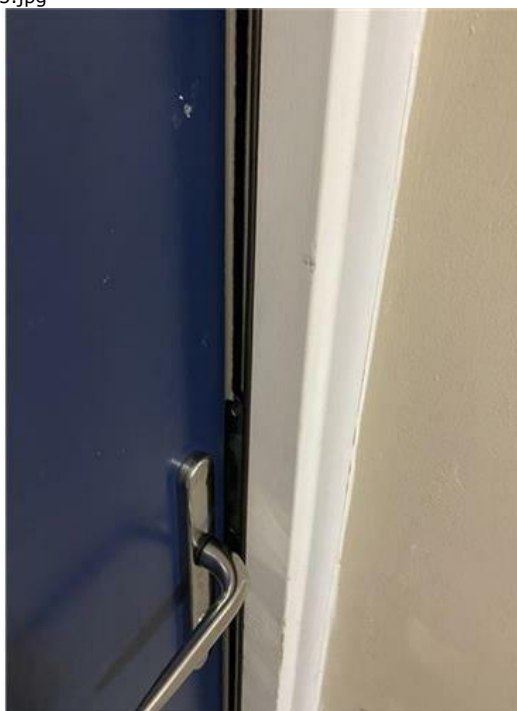
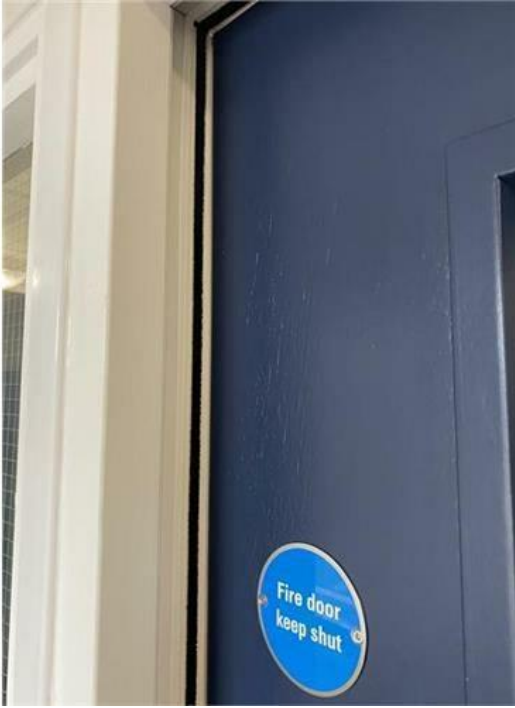
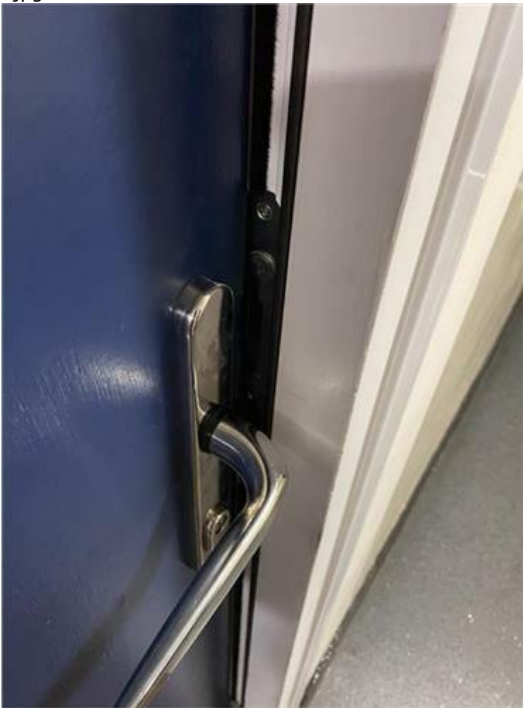
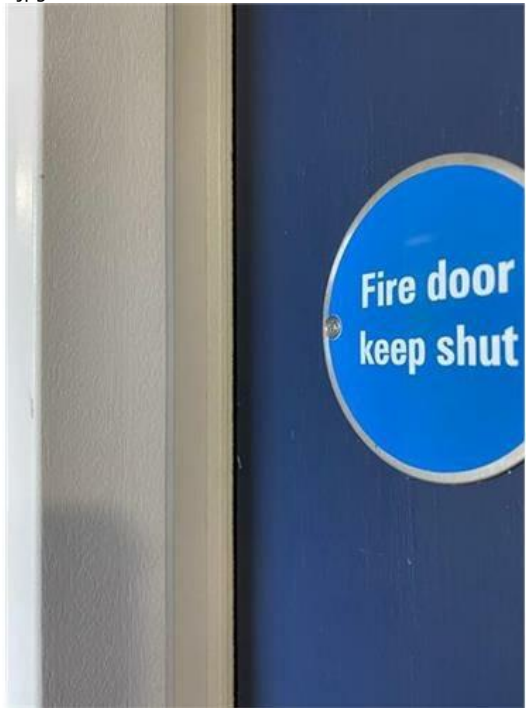
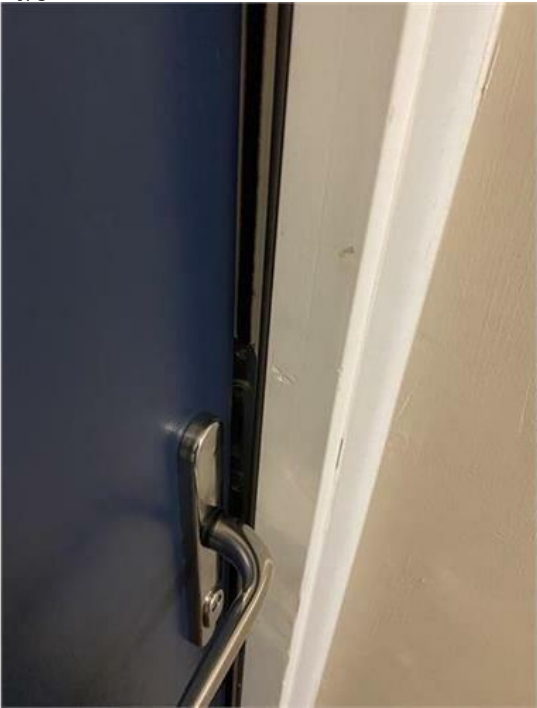
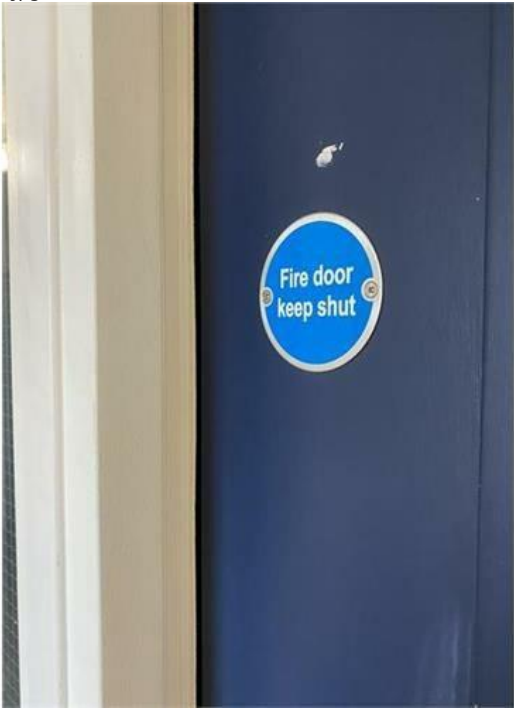
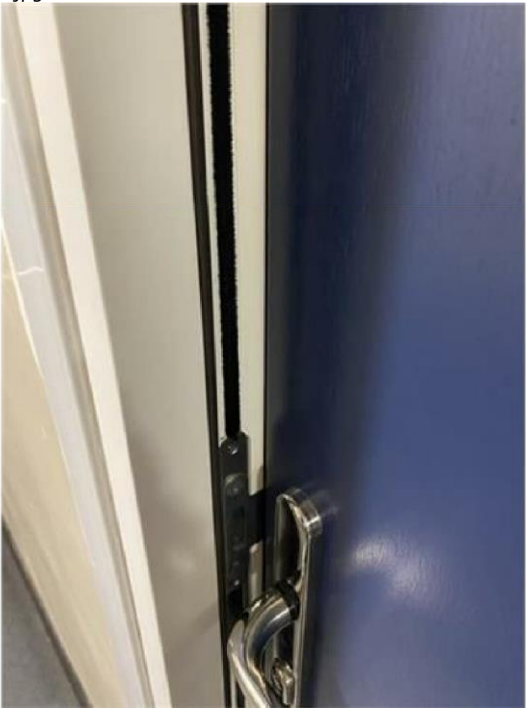
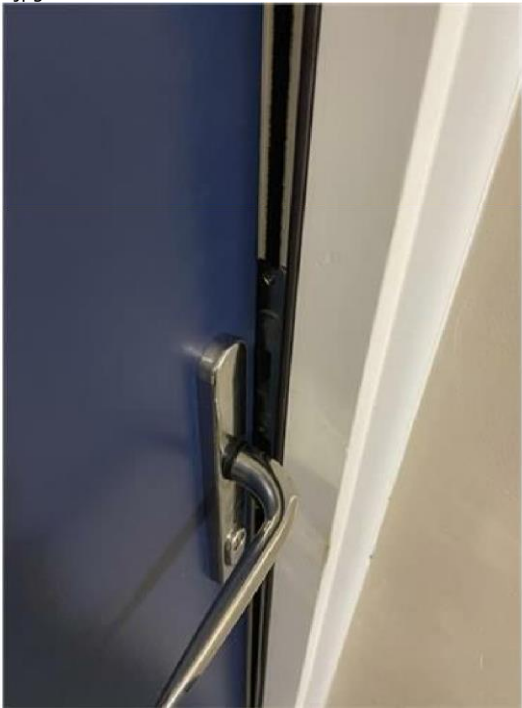
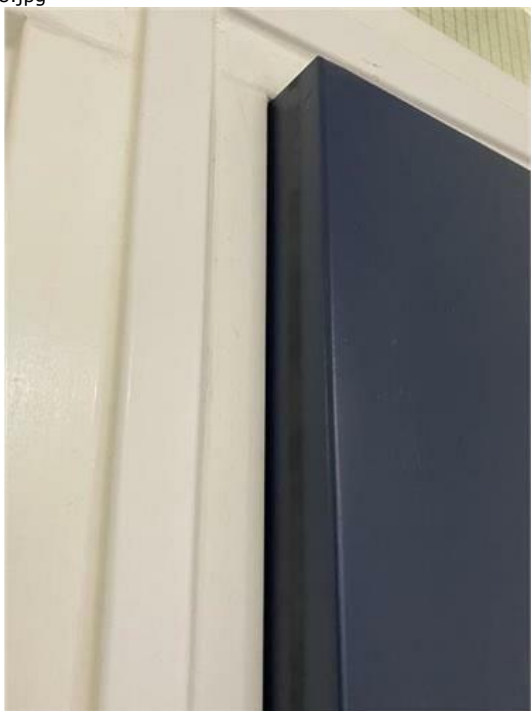
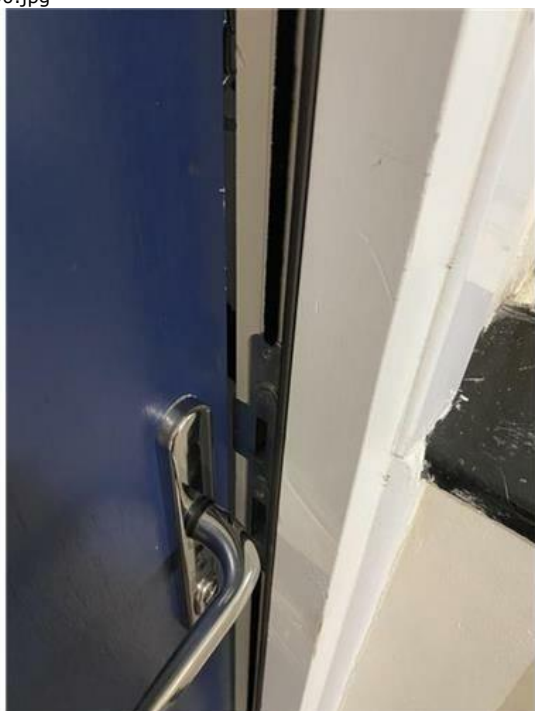
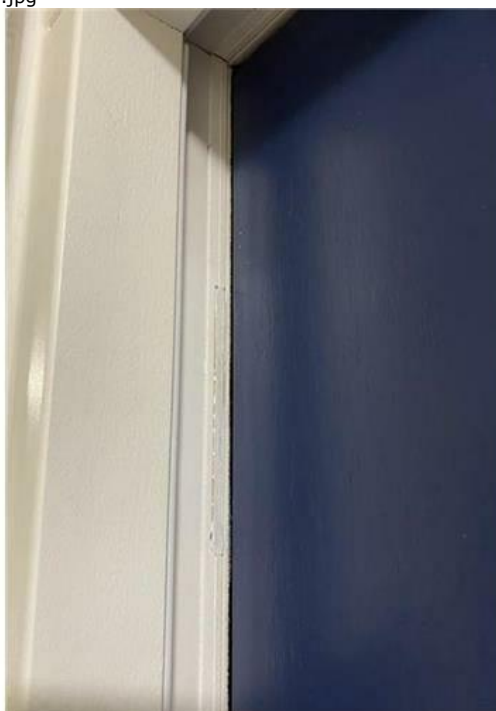
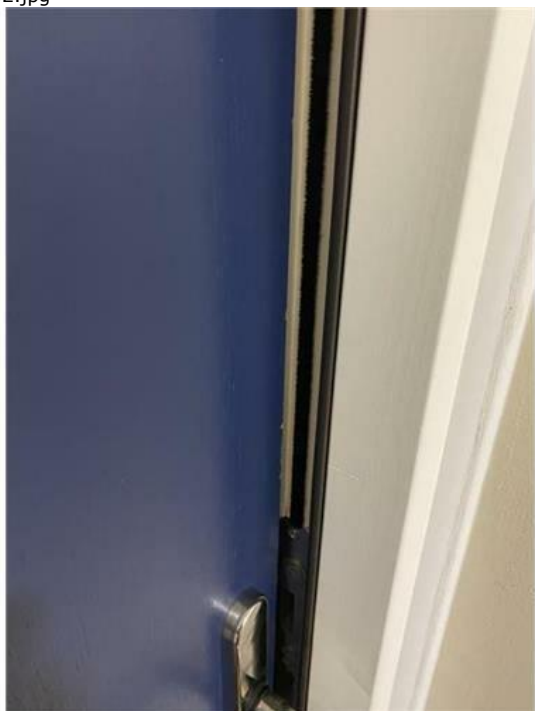
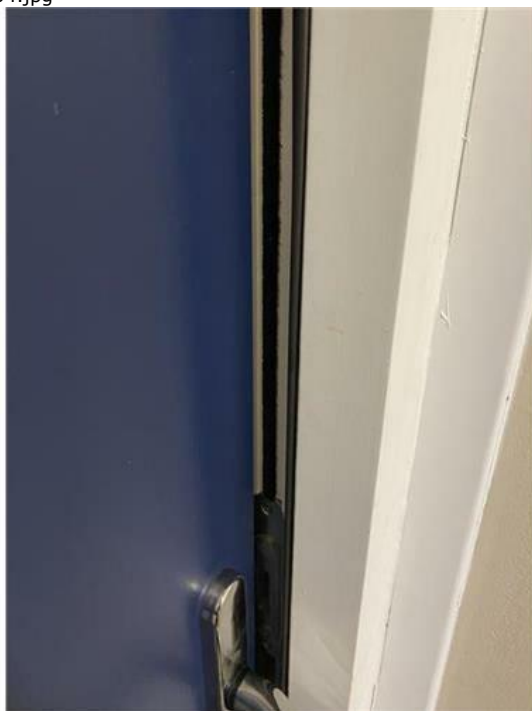
Ref	Sub Section	Question	Nonconformity	Recommendation	Location	Who is responsible	By When
13422317	J	Do the fire resisting door sets meet the appropriate standard?	Ineffective self closing devices.	Repair or replace the selfclosing devices to ensure fire doors close fully into their frames against the door stops.	Flats 90, 86, 84, 70, 68, 62, 34, 22, 23, 19, 16, 12, 4, 1. Stair, chute and lobby doors on 16, 13, 12, 11, 8, 7, 6, 4, 3, 2, 1.	Statutory requirement for the Client	09/04/2025

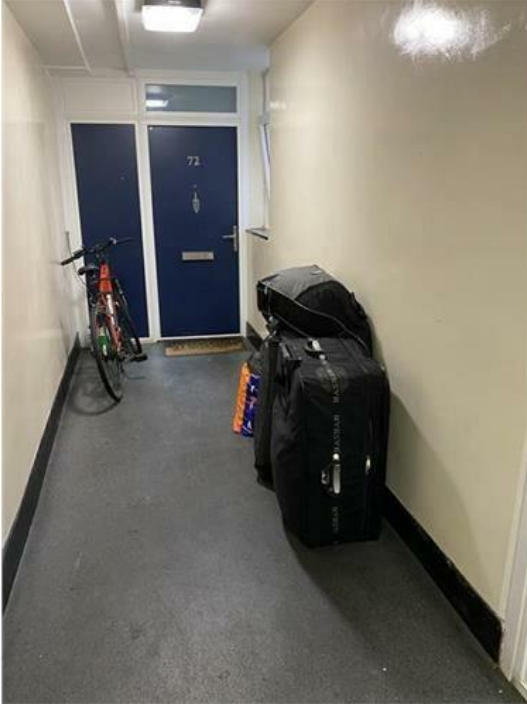
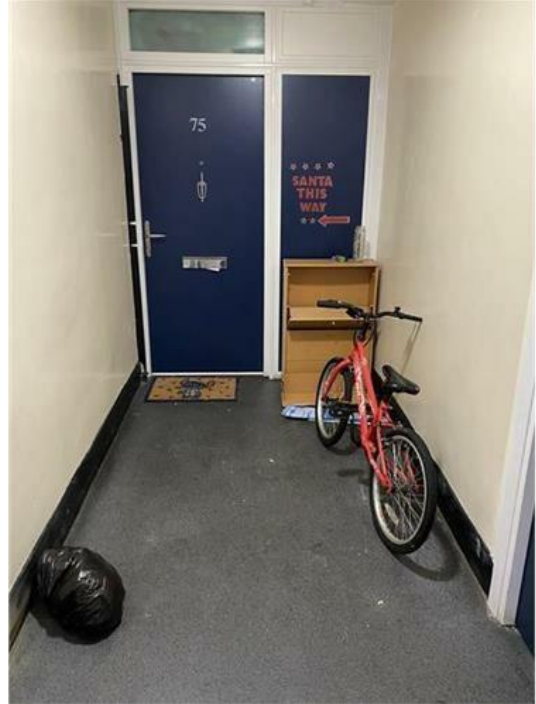
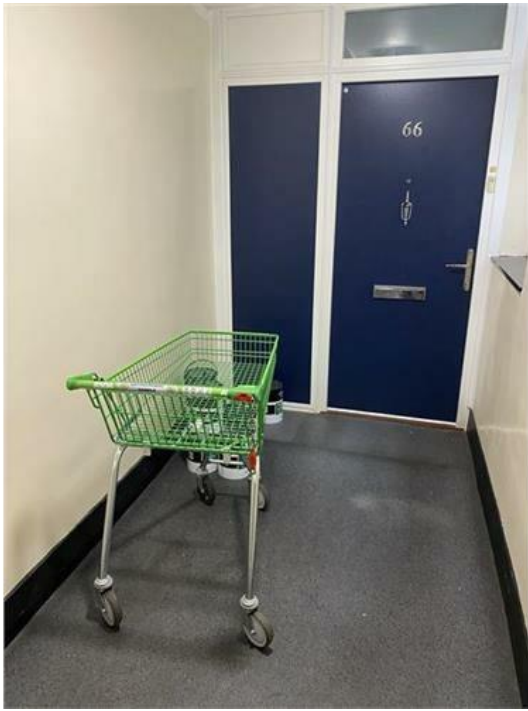
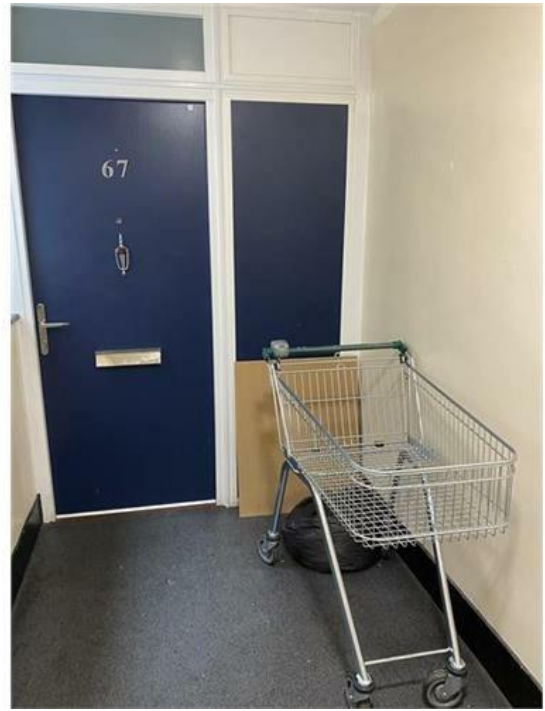
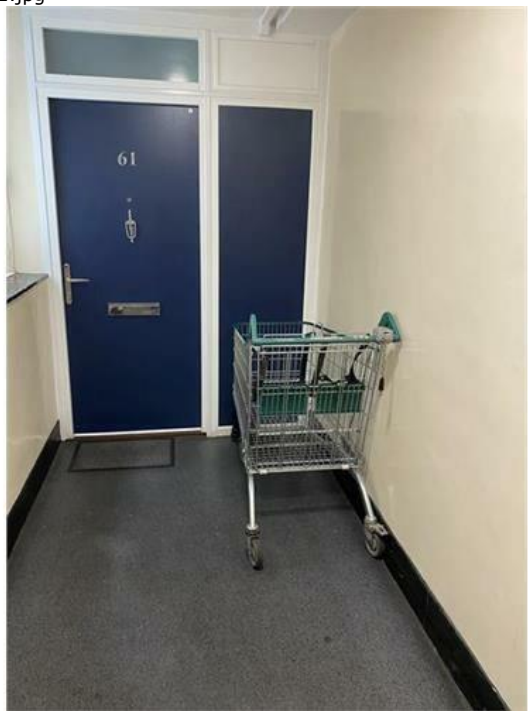
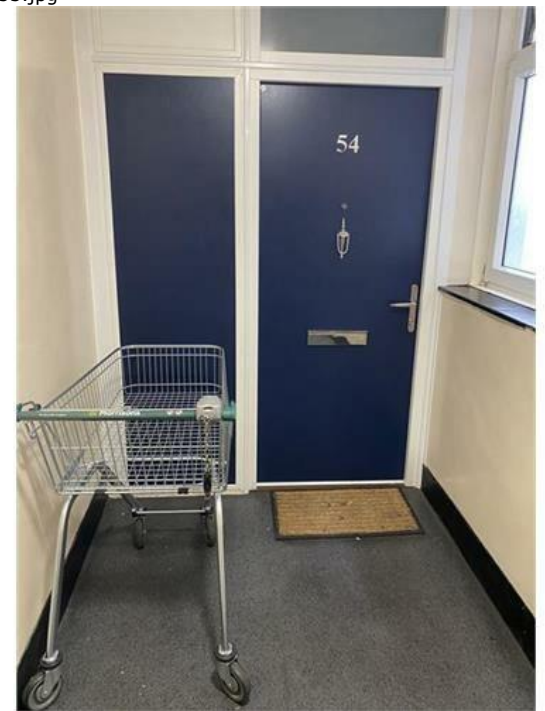
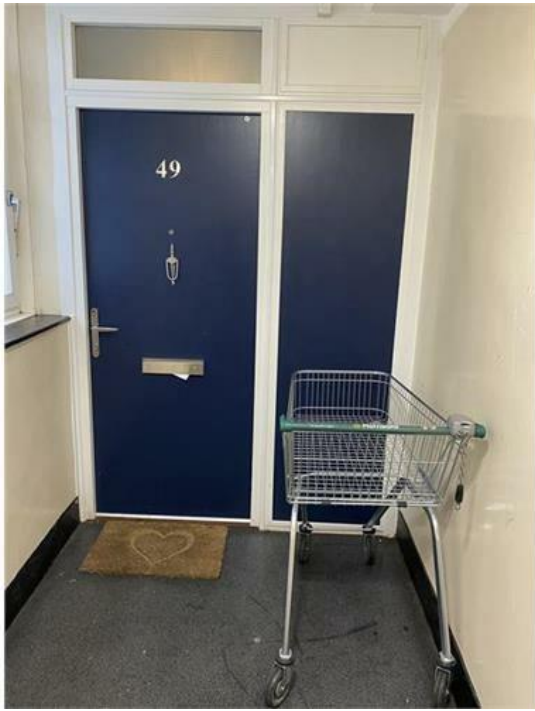
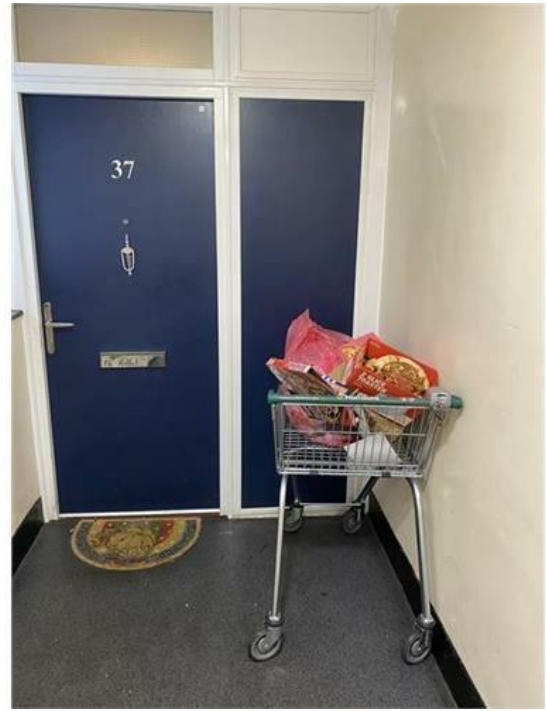
Ref	Sub Section	Question	Nonconformity	Recommendation	Location	Who is responsible	By When
13422322	5.0.D	Are house keeping arrangements satisfactory?	The escape route is obstructed.	The items obstructing the escape route must be removed and the means of escape kept clear.	O/S Flats 72, 75, 66, 67, 61, 54 and 49.	Statutory requirement for the Client	08/06/2025

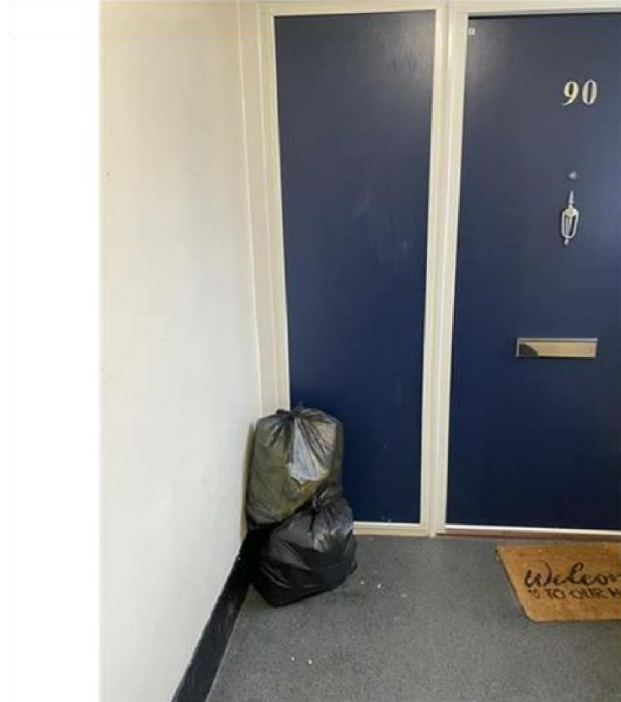
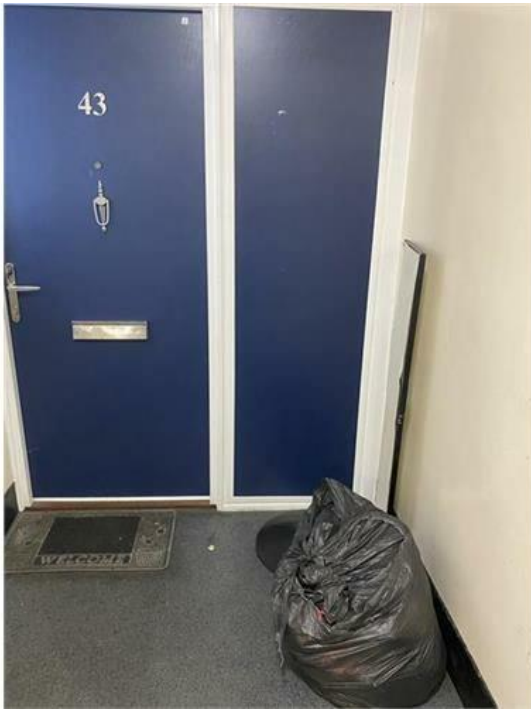
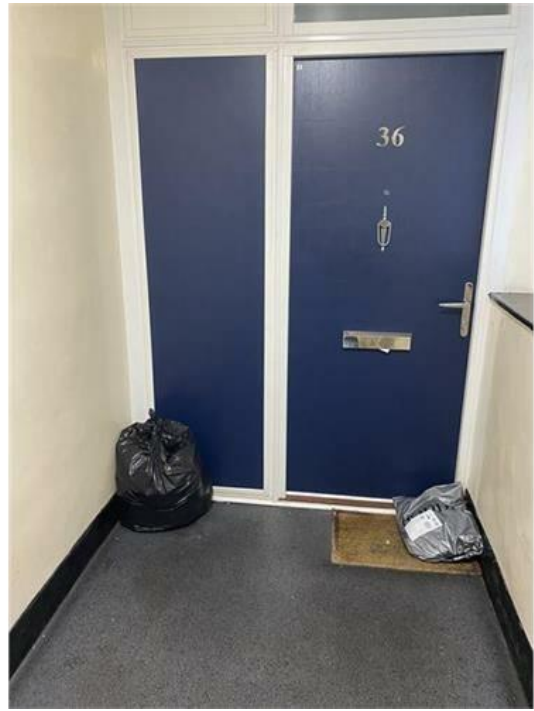
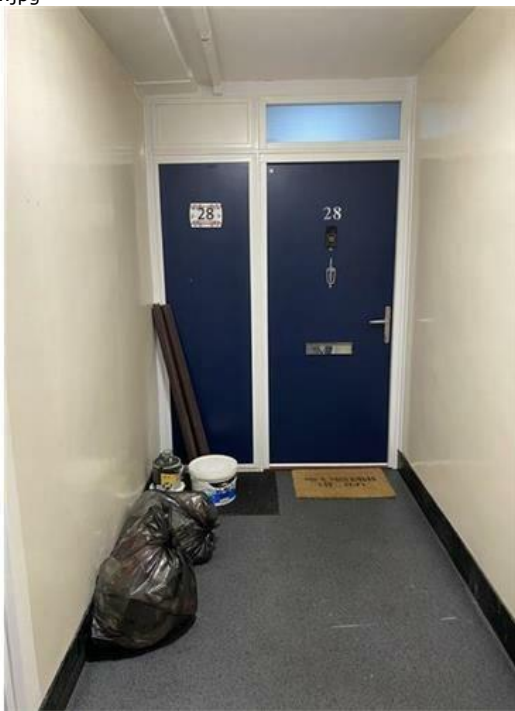
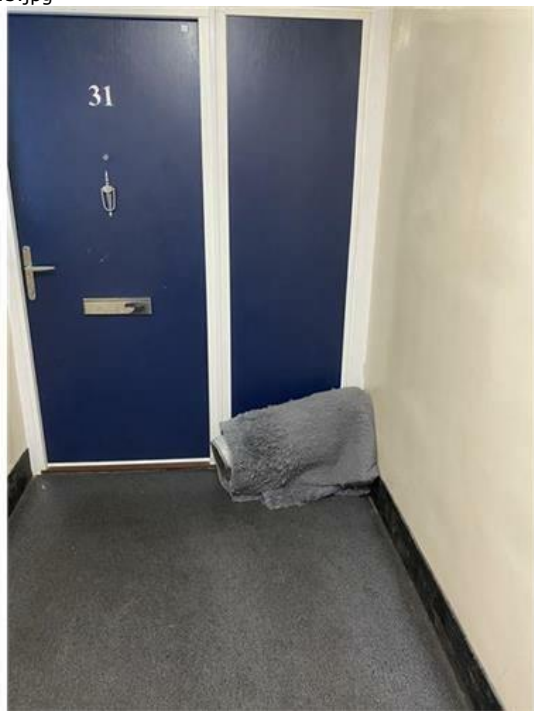
Ref	Sub Section	Question	Nonconformity	Recommendation	Location	Who is responsible	By When
13422321	A	Are house keeping arrangements satisfactory?	Combustible materials are located/stored in the escape routes.	Items that are a source of fuel or are combustible and likely to increase the fire loading or spread of fire, should not be located on any corridor, stairway or circulation space that will be used as an escape route. Therefore, the combustible materials stored in the escape routes must be removed.	O/S Flats 90, 43, 36, 28 and chute room on the 13th Floor.	Statutory requirement for the Client	08/06/2025

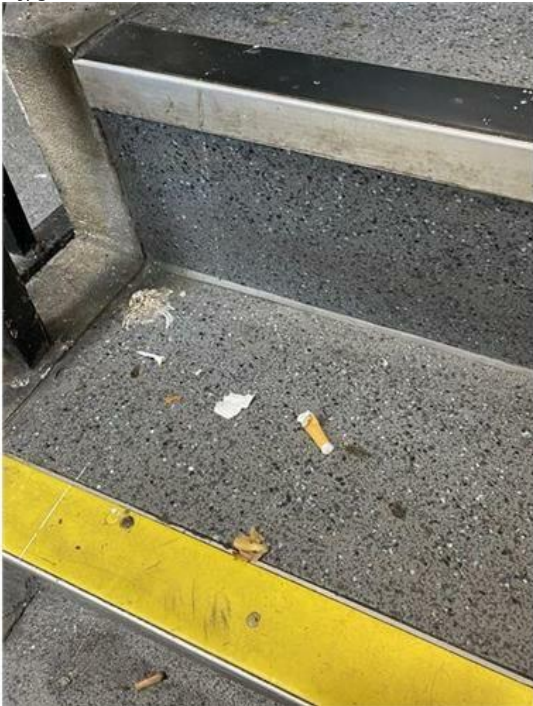
IMG\_7020.jpg

Ref	Sub Section	Question	Non-conformity	Recommendation	Location	Who is responsible	By When
13422324	B	Is a suitable 'no smoking' policy in place?	Evidence of unauthorised smoking was found.	Management are to apprise all relevant persons on the company smoking policy.	13th Floor Stair Landing.	Statutory requirement for the Client	08/06/2025

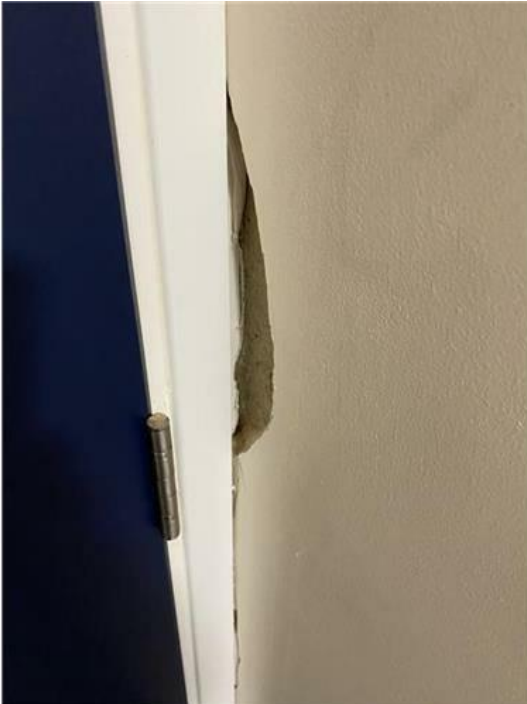
IMG\_7053.jpg

Ref	Sub Section	Question	Non-conformity	Recommendation	Location	Who is responsible	By When
13422320	C	Are the fire resisting partitions present installed and maintained to the appropriate standards?	The fire resisting partitions are in a poor state of repair.	Replace or repair the existing partition with approved materials which will provide the required level of fire resistance.	FFirst Floor Store	Statutory requirement for the Client	08/06/2025

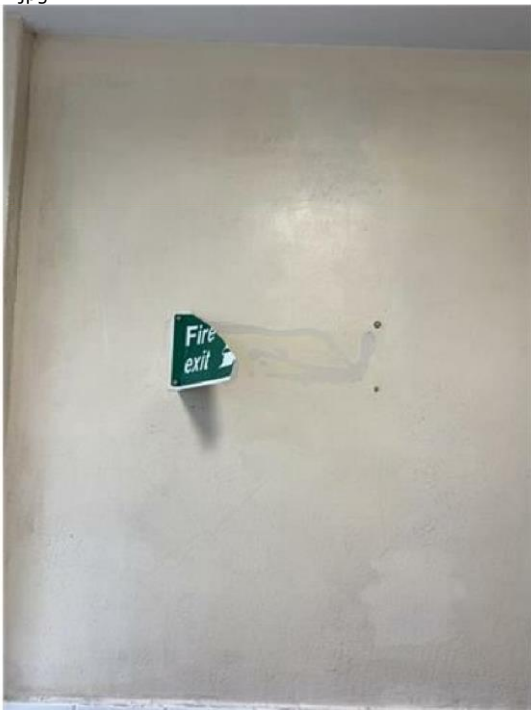
IMG\_7017.jpg

Ref	Sub Section	Question	Non-conformity	Recommendation	Location	Who is responsible	By When
13422325	H	Are there adequate and suitable fire safety signs and notices displayed in the appropriate places throughout the premises?	A number of fire action notices were found to be defaced or incomplete.	The notices should be completed in full with the location of the assembly point and the number to call in an emergency.	Defective Sign 16th Floor Stair Landing.	Statutory requirement for the Client	08/06/2025
