FIRNTEC
BUILDING COMPLIANCE

VISUAL STRUCTURAL APPRAISAL

89 Laburnum House

Bradwell Avenue
Dagenham
RM10 7AE

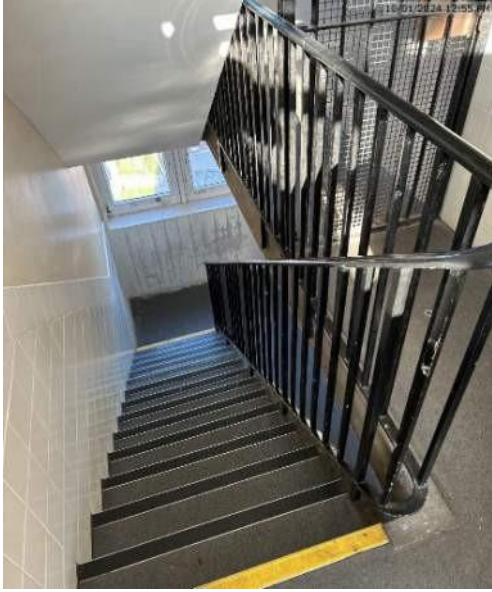
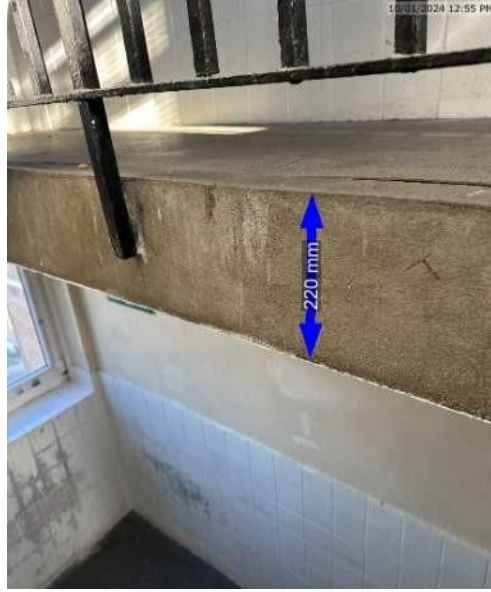
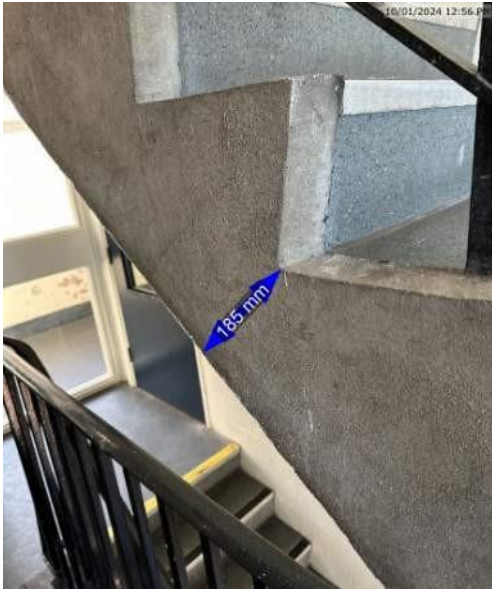
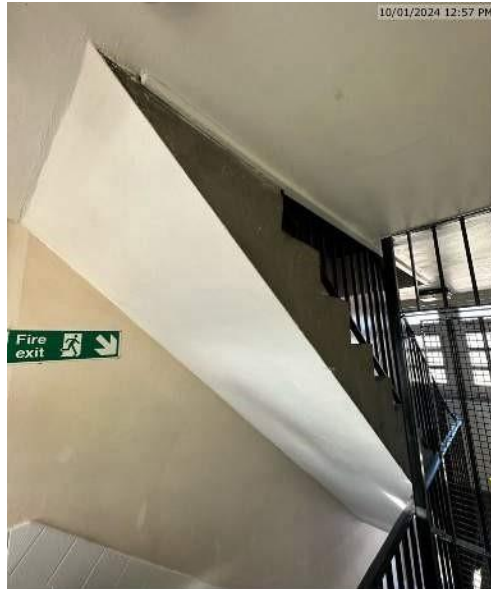
Reference: Internal
Location: 16th Floor
Created: 10/01/2024
Description: Photographs indicating stairwell area. Photographs also indicate floor slab thickness and stair stringer thickness.
Assigned To: Internal finishes
Reviewed By: Ruben Wood

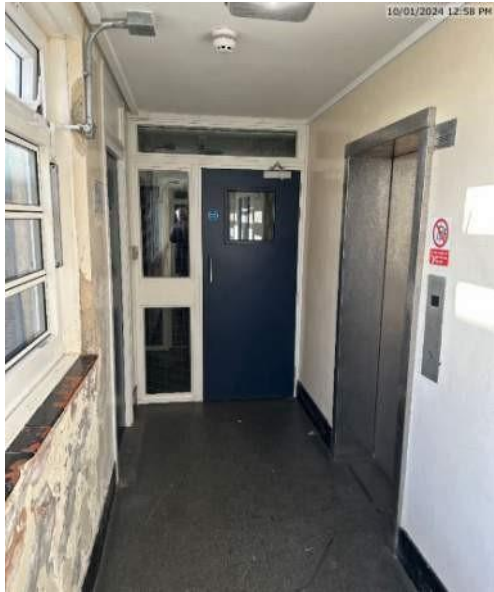
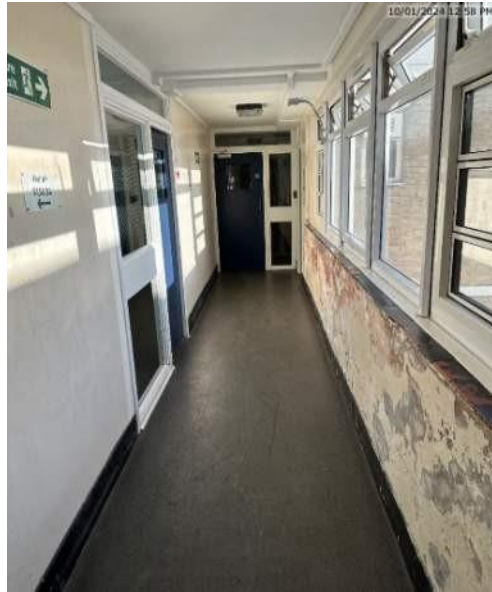
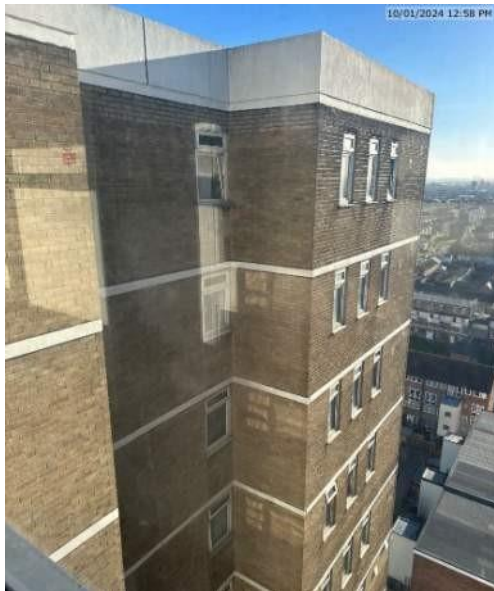
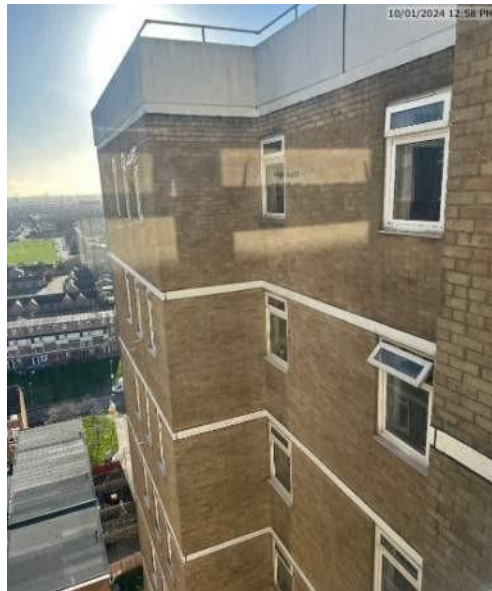
Reference: Internal
Location: 16th Floor
Created: 10/01/2024
Description: Photographs indicating corridor forming access to flats and lift shaft. Please note all access doors open and close with ease with no binding. Photos also indicate external elements of the building.
Assigned To: Internal finishes
Reviewed By: Ruben Wood

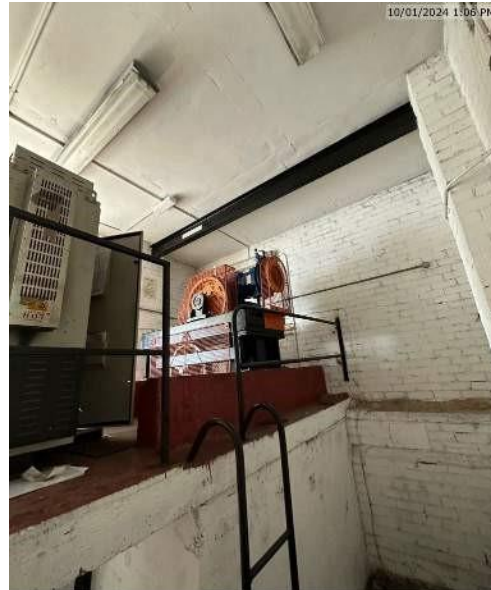
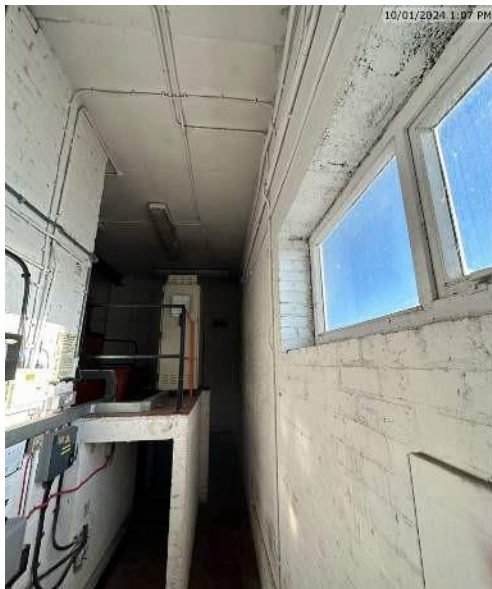
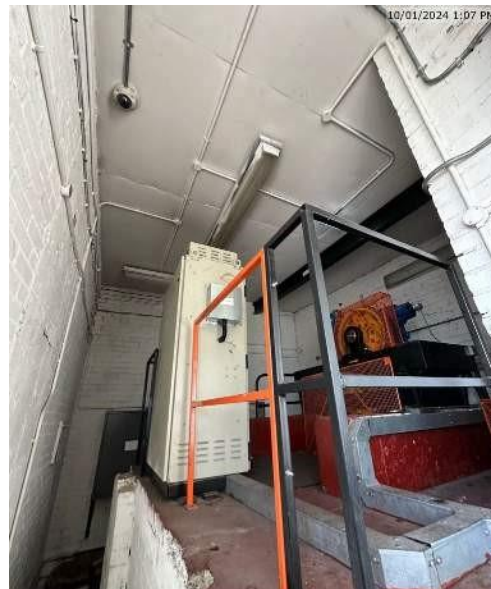
Reference: Internal
Location: Internal roof level
Created: 29/11/2023
Description: Photographs indicating internal plant room which houses the motors for the lift shafts. Please note walls consist of a brick finish with concrete sections also. Please note the floor consist of a concrete finish and also the ceiling. Please note the steel beams at ceiling level supported on brick piers. There are open joints to the brickwork and this occurs between the first and second course at ceiling level.
Assigned To: Internal finishes
Reviewed By: Ruben Wood

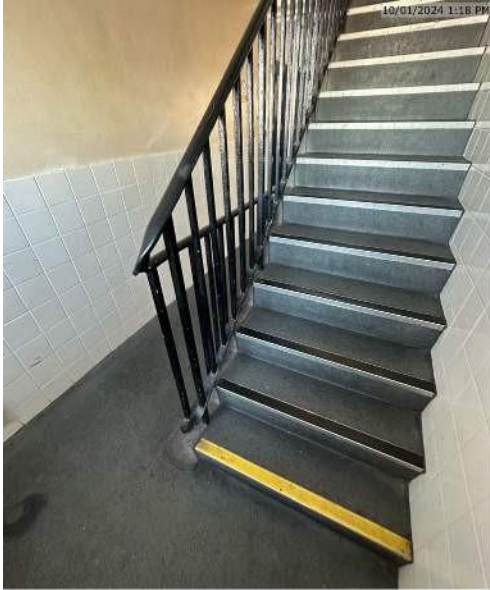
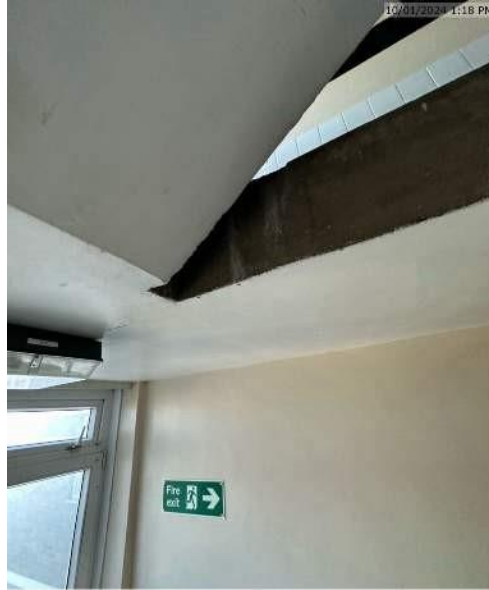
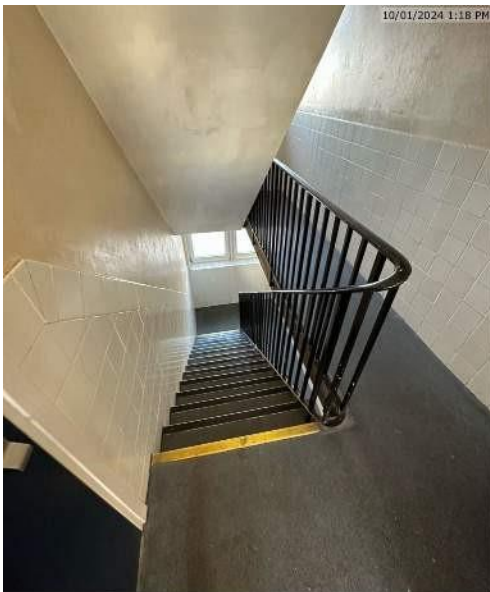
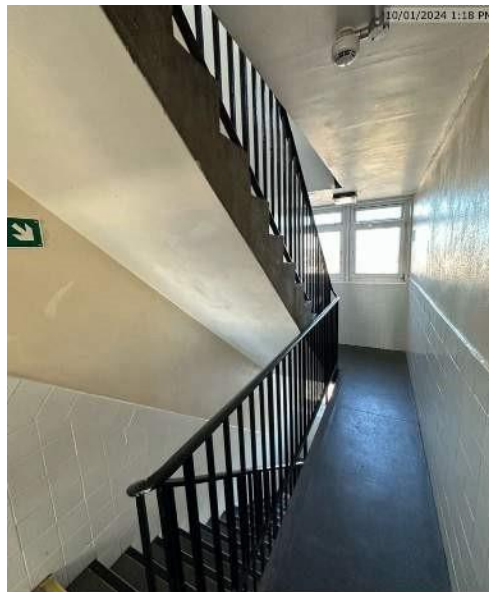
Reference: Internal
Location: 8th Floor
Created: 10/01/2024
Description: Photographs indicating stairwell area. Photographs also indicate stair stringer thickness and floor slab thickness.
Assigned To: Internal finishes
Reviewed By: Ruben Wood

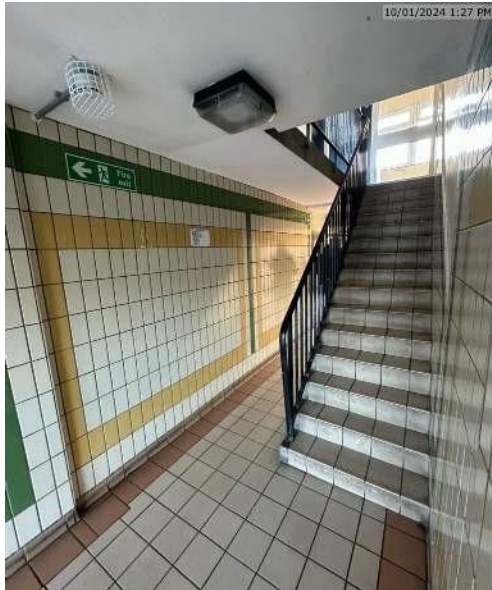
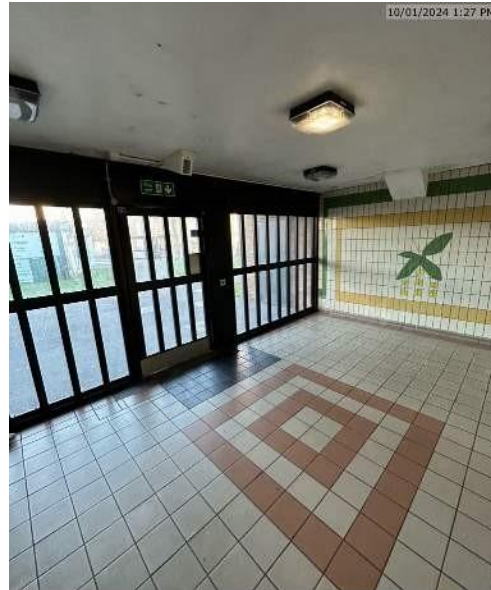
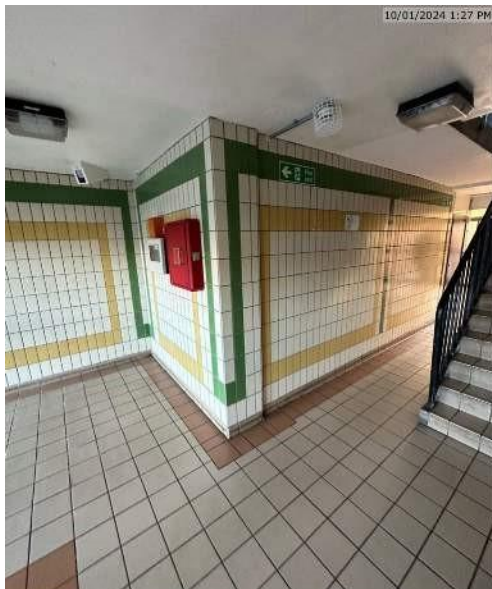
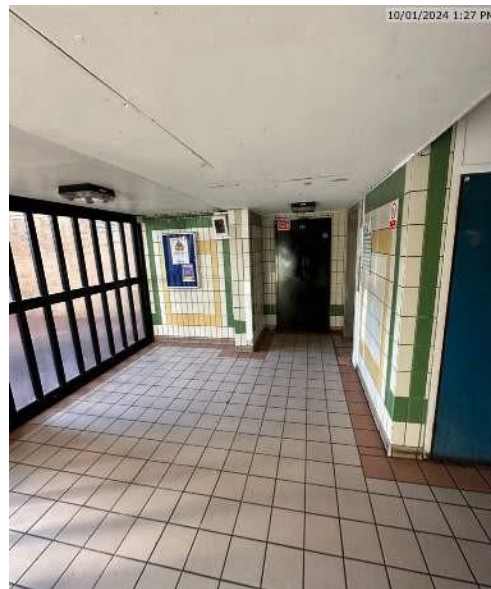
Reference: Internal
Location: Ground floor
Created: 10/01/2024
Description: Photographs indicating internal lobby/ entrance area with access to lift shafts.
Assigned To: Internal finishes
Reviewed By: Ruben Wood

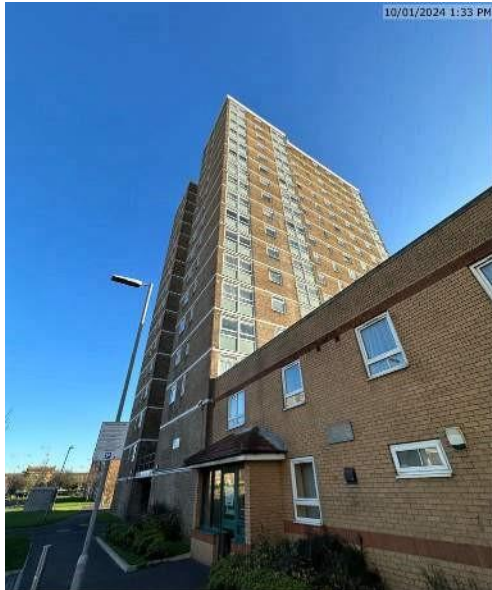
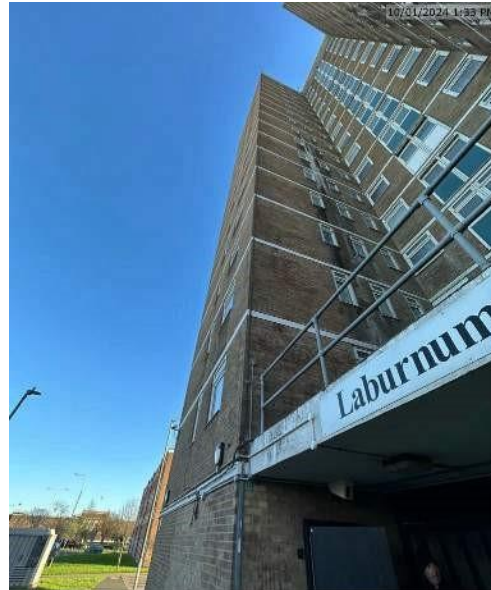
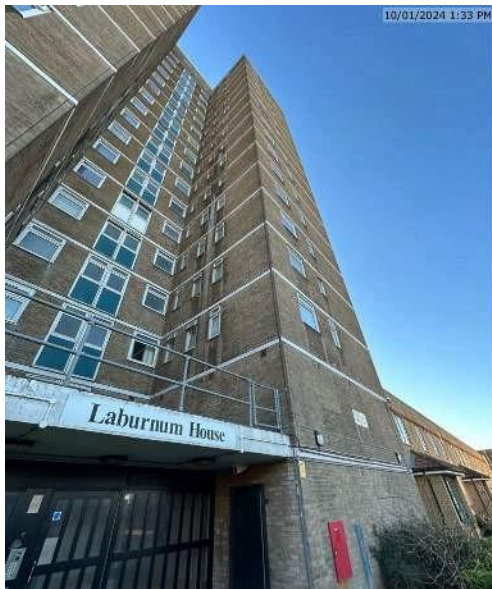
Reference: External
Location: External
Created: 10/01/2024
Description: Photographs indicating external elevations and elements of the building.
Assigned To: External elements
Reviewed By: Ruben Wood
